Amtrak Passenger Train 501 Derailment
DuPont, Washington
December 18, 2017

NTSB/RAR-19/01
PB2019-100807

NTSB/RAR-19/01
PB2019-100807
Notation 58913
Report Date: May 21, 2019

Railroad Accident Report

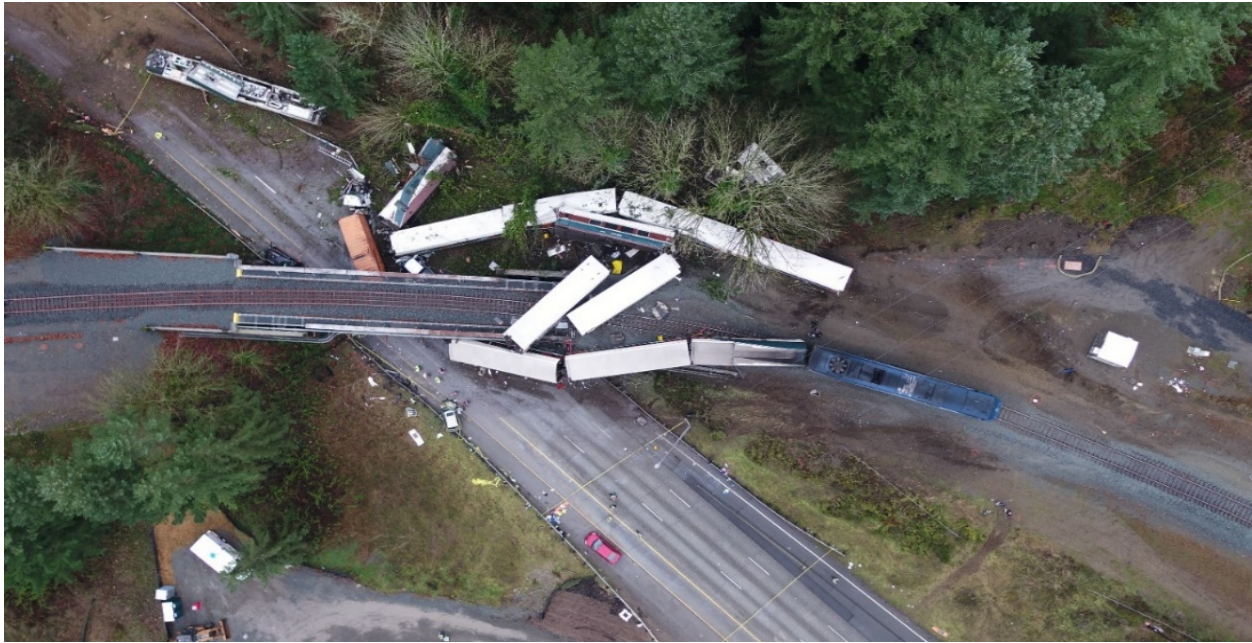
About 7:34 a.m., the lead locomotive and the following seven coaches derailed, the locomotive and several coaches careened down a wooded embankment, some reaching and blocking the southbound lanes of I-5. Two coaches came to rest on the overpass and several cars went down the embankment to the left of the overpass while the trailing unit (AMTK 181) remained on the rail just short of the overpass.

Figure 2. Aerial photograph of accident. (Photo provided by Washington State Police [WSP].)

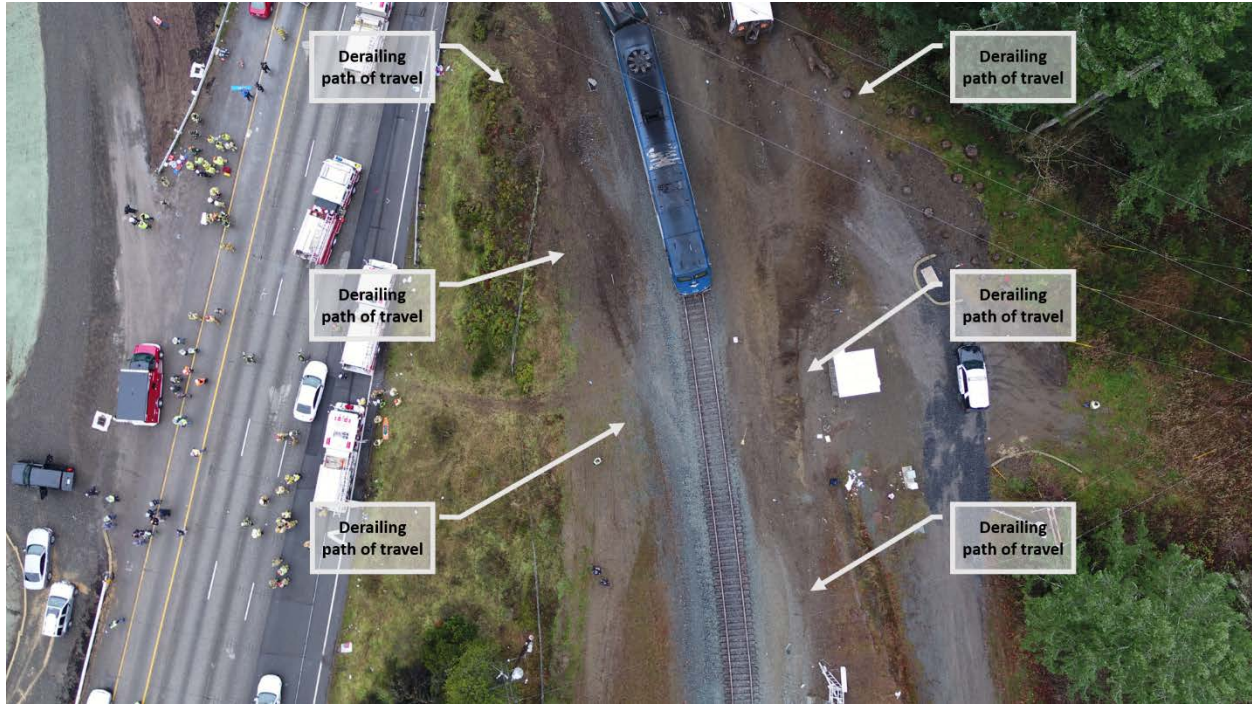
The railcars trailing behind AMTK 7422 (10) then traveled to the left of the main track. In the aerial photograph visible marks in the ballast and soil show the path of travel of the separated train. (See figure 14.)

Figure 14. Derailing path of travel of Amtrak 501. (Photo provided by WSP.)

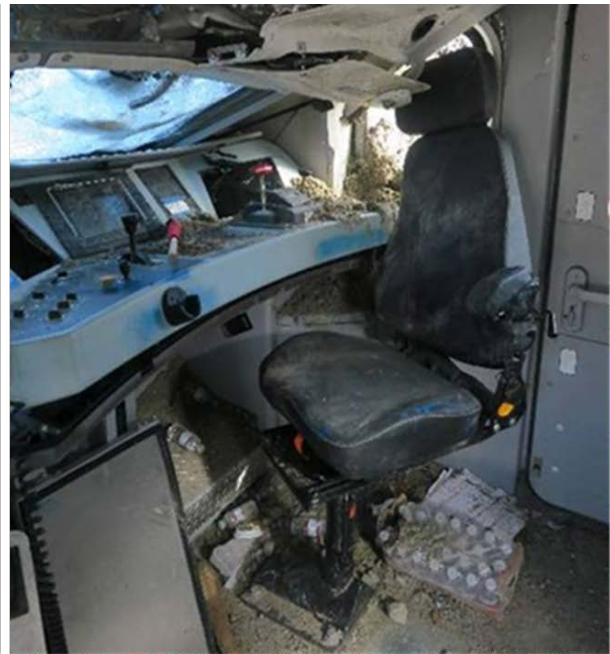
Damage to the interior of the operating cab was constrained primarily to the leading end, most notably at and above the front glazing (windshield). The vertical space of the cab interior was reduced to about 19 inches between the operator's desk and the ceiling, and to 66 inches from the floor to the ceiling. The height above the seats was reduced to 66.5 inches. All doors, both side doors, and the machinery room access door, were fully functional after the accident. The cab ceiling emergency exit hatch was dislodged from the vehicle. The hatch is comprised of two parts; the upper, or outer, part came to rest in the wooded area between the track and the interstate, and the inner portion was inside the cab. Investigators estimated the locomotive lost about 5 percent of its occupied volume in the cab. Figure 19 is a cutaway illustration of the locomotive cab showing the cab design and underlying structure and an interior photograph of the accident cab taken from the left side of the cab towards the engineer's seat on the right.

Photograph of damaged locomotive cab.

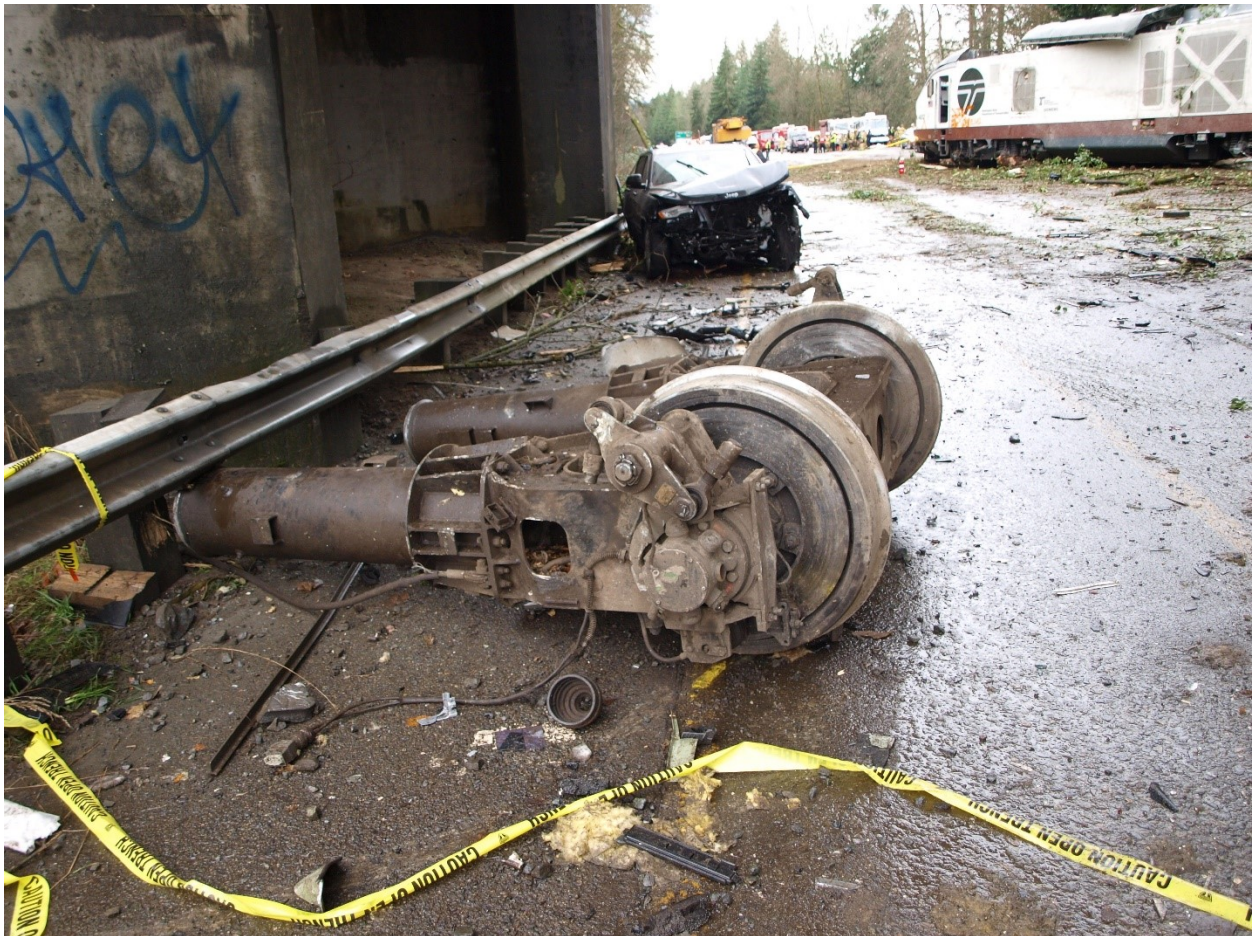
A green Kia Soul (Kia) and a black Jeep Grand Cherokee (Jeep) were struck by the rolling assembly weighing about 4,500 pounds that had detached from AMTK 7424 (8). (See figure 25.) The rolling assembly struck the front hood of the Kia and the rear of the Jeep; causing both drivers to lose control of their vehicles. The driver of the Jeep reported to investigators that AMTK 7424 (8) also struck his vehicle. Both vehicles sustained extensive crush damage resulting from the impact with the rolling assembly. The driver of the Kia was pinned inside of her vehicle when the engine block was shoved rearward, collapsing the dashboard and steering column onto her. (See figure 26.) The driver had to be extricated by first responders but sustained only minor injuries in the accident. After being struck by the rolling assembly, the Jeep rotated 180° striking the metal guardrail before coming to final rest. (See figure 27.) The Jeep occupant also sustained minor injuries in the accident.

Figure 25. Detached rolling assembly and Grand Cherokee. (Photo provided by WSP.)

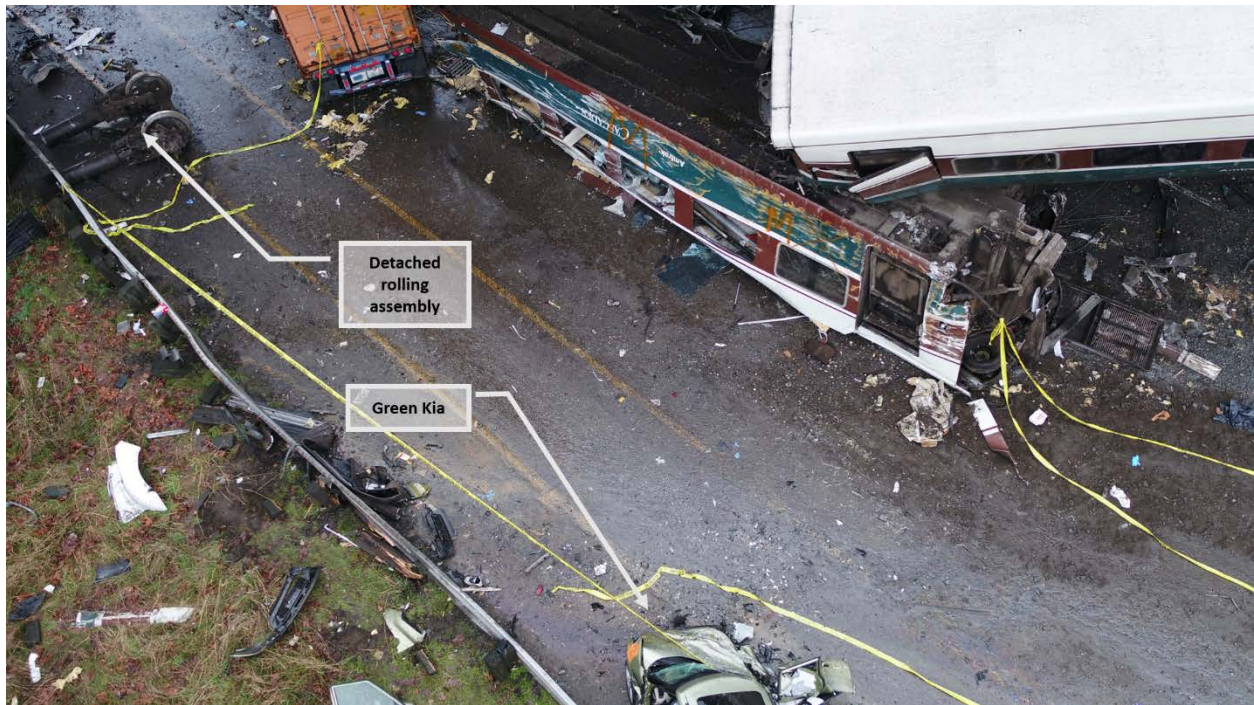
Figure 26. Green Kia and rolling assembly on I-5. (Photo provided by WSP.)

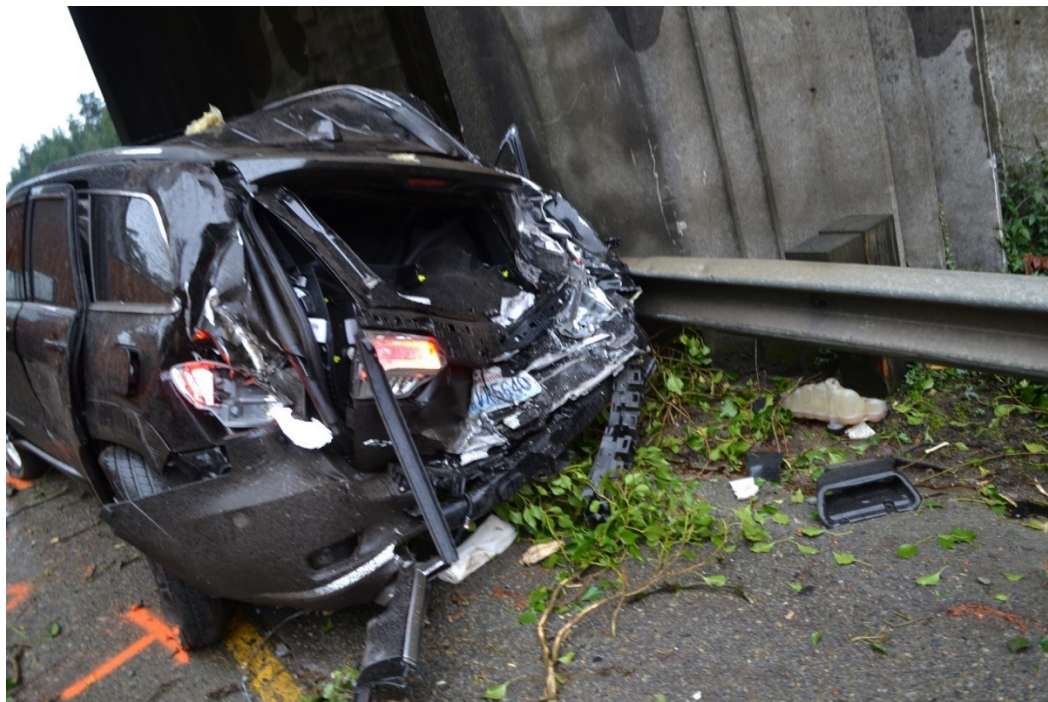
Figure 27. Damaged Jeep Grand Cherokee. (Photo provided by WSP.)

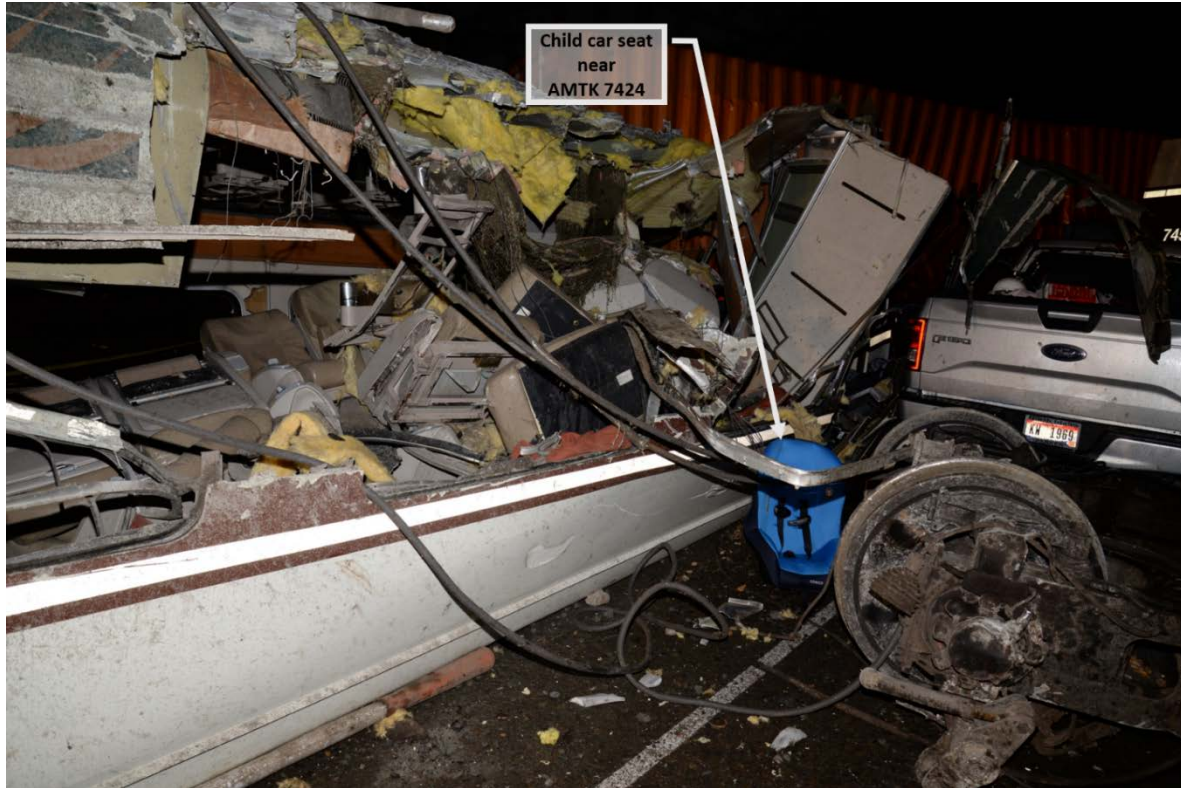
As discussed above in section 1.13.6, restricting the fore and aft movement or compartmentalizing a passenger involved in an accident is effective in minimizing injuries. Currently there are no features in passenger railcars that allow a parent to secure their child safety seat (car seat). In this accident, a family carrying a car seat with an infant boarded train 501 and sat in AMTK 7421 (11). The parents reported that they were unaware that the train would not have securement straps necessary to belt the car seat into one of the seats in the railcar. Subsequently, the car seat containing the child was placed on top of a table during the journey. Just prior to the derailment; the father reported that he removed the child from the car seat and entered the lavatory. The car seat was left on top of the table. During the derailment, the unrestrained car seat was ejected out of AMTK 7421 (11). The car seat was recovered outside near AMTK 7424 (8) near a disconnected rolling assembly. (See figure 32.)

Figure 32. Child car seat near AMTK 7424 (8). (Photo provided by the Federal Bureau of Investigation.)

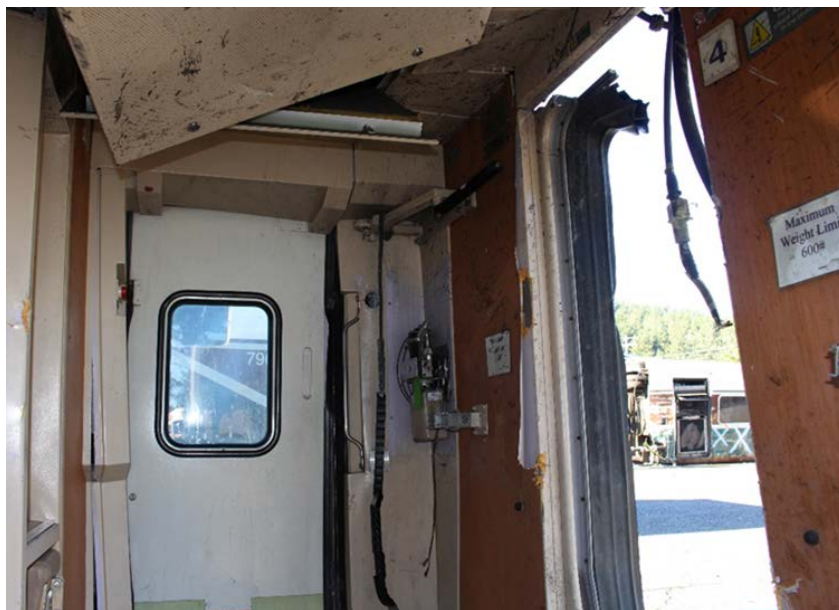
Only one wheelchair lift was recovered from the scene. Components from the second lift were recovered. Due to the extensive damage to the railcar and to the recovered wheelchair lift, it was not possible to determine which wheelchair lift had been recovered from the debris. Figure 34 shows the interior damage to AMTK 7504 (7) and the location where the wheelchair lifts were mounted prior to being torn away from the railcar structure.

Figure 34. Photograph of missing wheelchair lift and damage to AMTK 7504 (7).

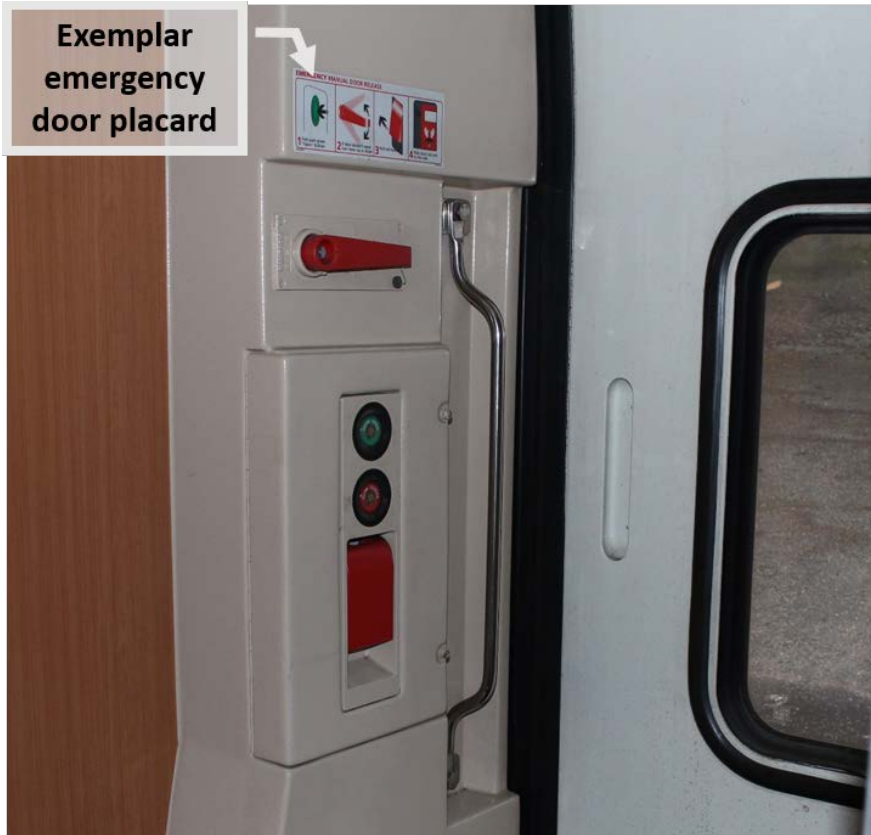
present but did not possess the required photoluminescence by regulation. The derailment occurred prior to sunrise. (See figure 37.)

Figure 37. Exemplar emergency door showing instruction placard.
