RAIL TRANSPORTATION SAFETY INVESTIGATION REPORT R19T0147

EMPLOYEE FATALITY

Canadian National Railway Company
Remote control locomotive system
Dual hump yard assignment YDHF60
Mile 0.0, Halton Subdivision
MacMillan Yard
Vaughan, Ontario
15 August 2019

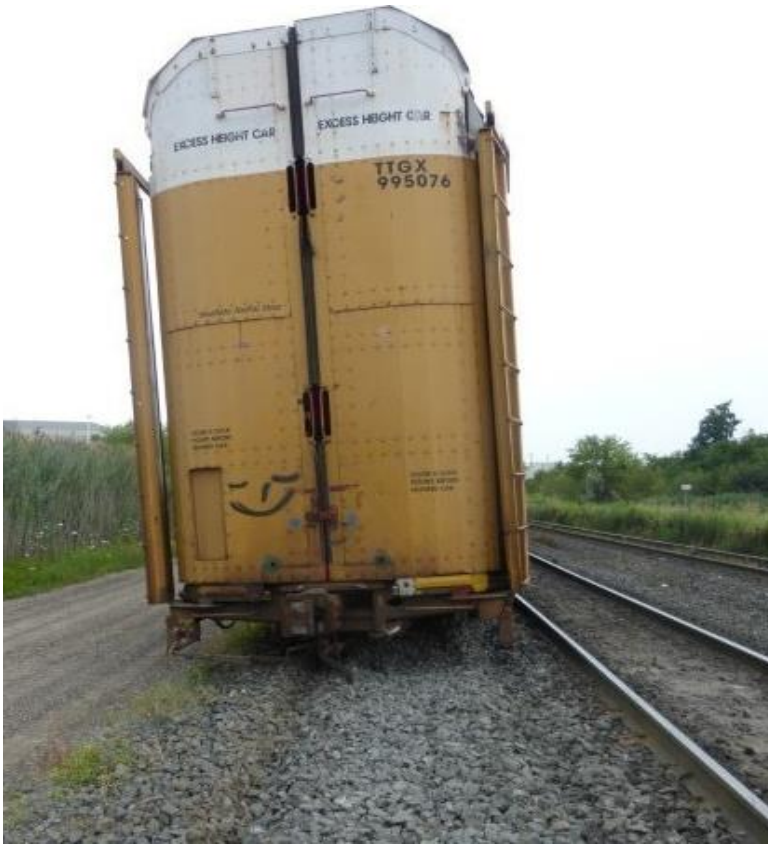
Figure 5. Trailing B-end truck of 26th car TTGX 995076 derailed; -end truck remained on the rails (Source: TSB)

The 26th car, empty autorack car TTGX 995076, had derailed but came to rest upright. The leading A-end truck did not derail but all 4 wheels of the trailing B-end truck were derailed in the ballast on the west side of the track, just north of the W100 switch (Figure 5). As the car came to rest, it struck and damaged the W100 switch. The remainder of the head-end cars were inspected with no defects noted.

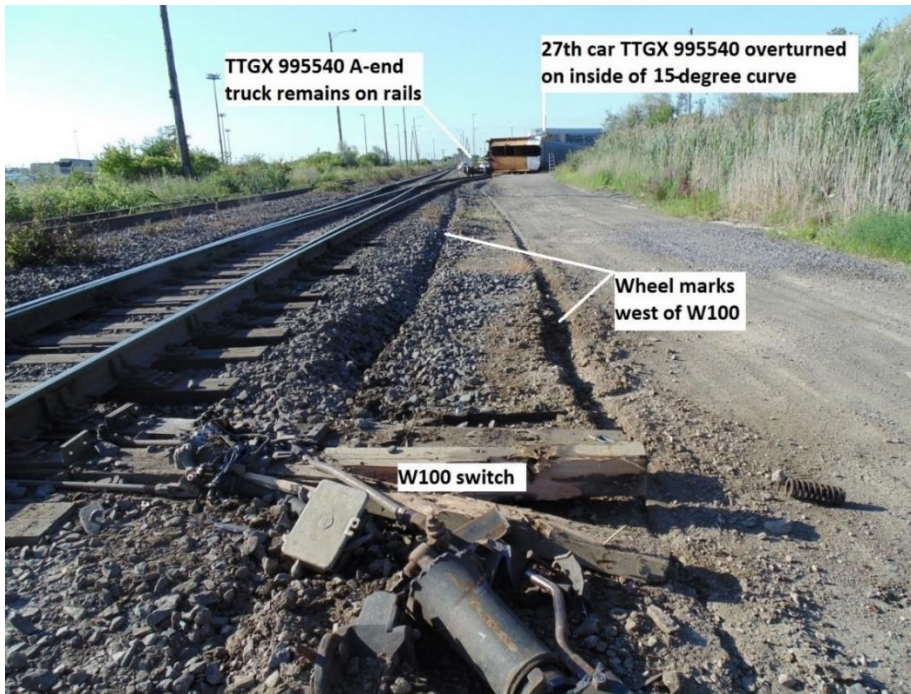
Figure 6. View southward from the W100 switch (Source: TSB)

From the W100 switch, wheel marks were observed in the ballast extending southward for about 400 feet. The marks in the ballast stopped near the leading end of the 27th car, TTGX 995540. The leading A-end truck of TTGX 995540 remained intact, did not derail and rolled along the track clear of the car. It came to a stop on the rails about 40 feet north of the car (Figure 6).

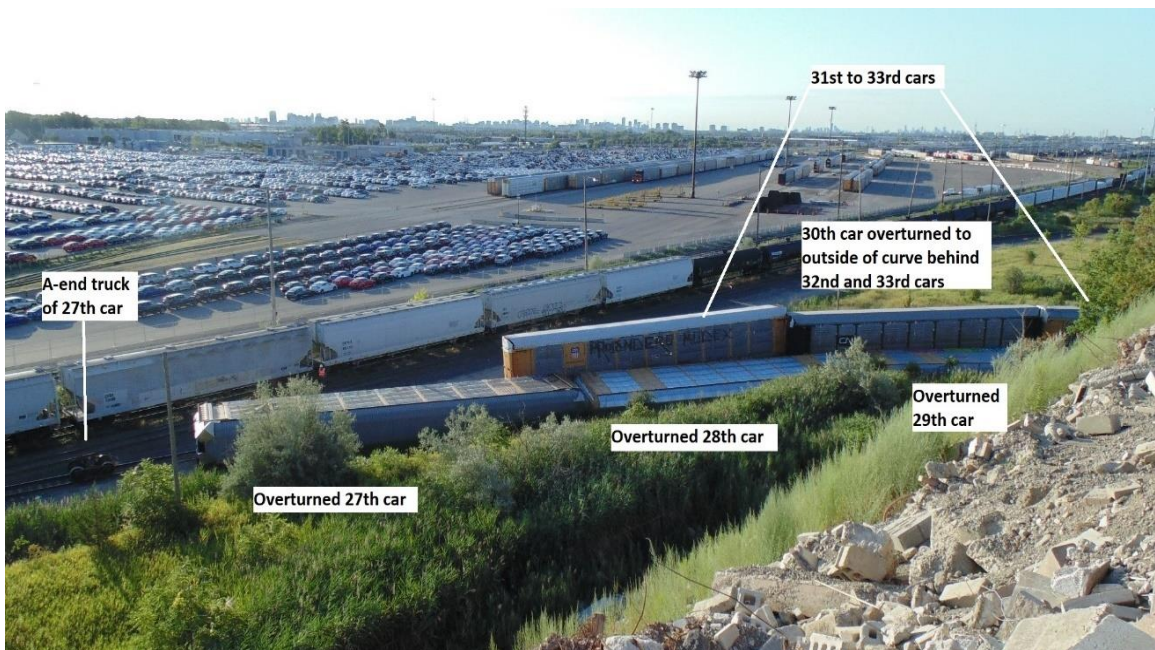
Figure 7. Occurrence site (Source: TSB)

The 27th, 28th, and the 29th cars were coupled together, had all rolled off their trucks and overturned on their sides on the inside of the 15-degree curve (Figure 7).

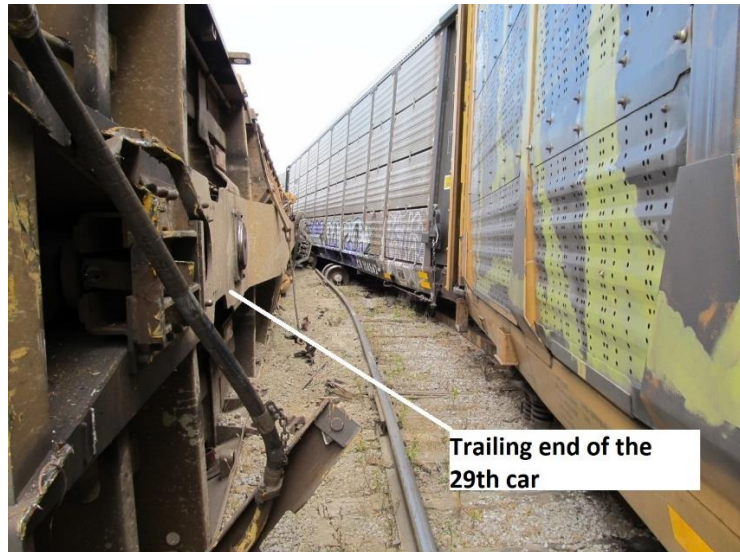
Figure 8. Looking from the trailing end of the 29th car as it came to rest about 2 feet from the inside rail of the curve. Note missing trucks (Source: Canadian National Railway Company)

Each of the 3 cars came to rest about 2 feet from the inside rail of the curve (Figure 8).

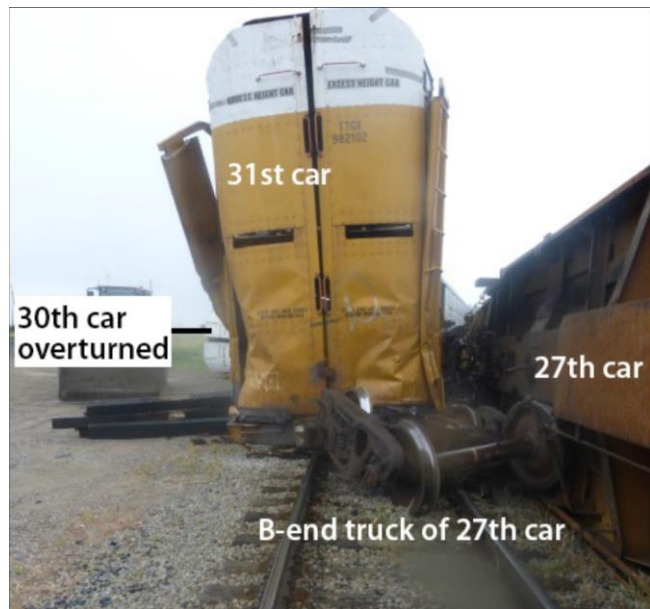
Figure 9. Leading end of 31st car TTXG 982102 and the trailing truck of 27th car (Source: TSB)

The 31st to the 34th cars remained upright and coupled together. The outer rail of the curve had rolled to the outside (eastward) beneath these cars. The 31st to 33rd cars derailed all wheels along the track, while only the wheels on the leading end of the 34th car had derailed (Figure 10).

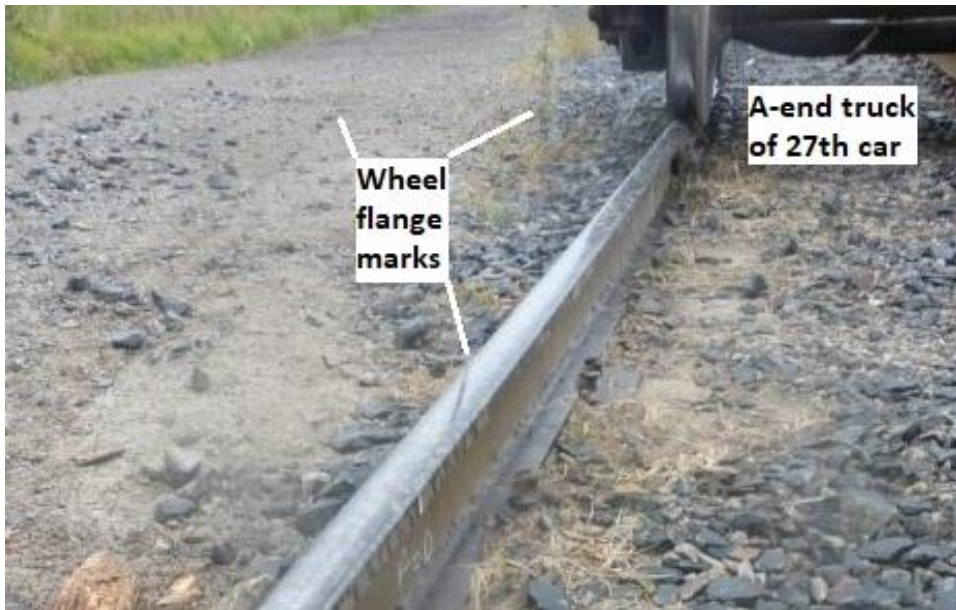
Figure 11. Wheel flange marks on rail head and ballast (Source: TSB)

Short wheel flange marks were observed on the running surface of the west rail in the exit spiral of the 15-degree curve that transitioned to a tangent section of W100. The marks were located about 5 feet north of the overturned 27th car. The marks extended from the gauge side to the field side of the rail at which point they dropped off to the west into the adjacent ballast on the inside of the curve, and continued northward to the W100 switch (Figure 11).

From the W100 switch, wheel marks were observed in the ballast extending southward for about 400 feet. The marks in the ballast ended near the leading end of the 27th car where short wheel flange marks on the running surface of the west rail in the exit spiral of the 15-degree curve identified the initial point of derailment. The short wheel flange marks were indicative of a derailment caused by wheel climb of the left-side wheels of the trailing truck of the 26th car. These observations were consistent with what are considered to be classic string-line derailment characteristics.

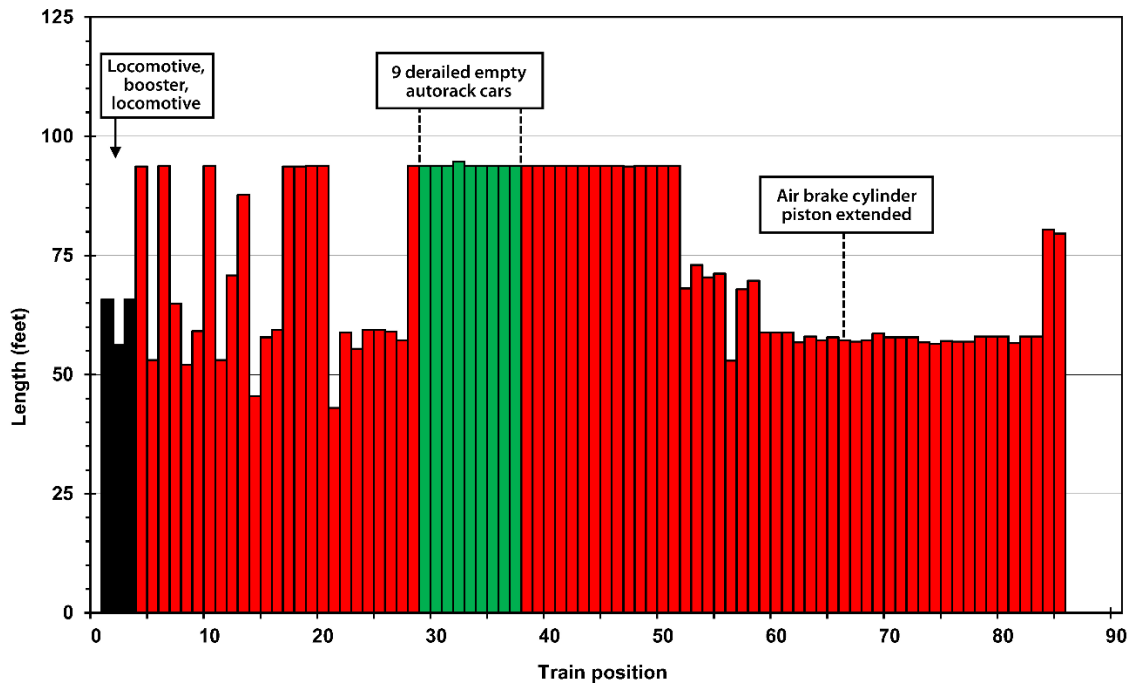
Figure 14. Assignment length profile (Source: TSB)

The assignment length profile (Figure 14) displays the positions of the locomotive hump set, the 9 long empty autorack cars that derailed and the car in the 63rd position that was observed to have its air brake cylinder piston extended.

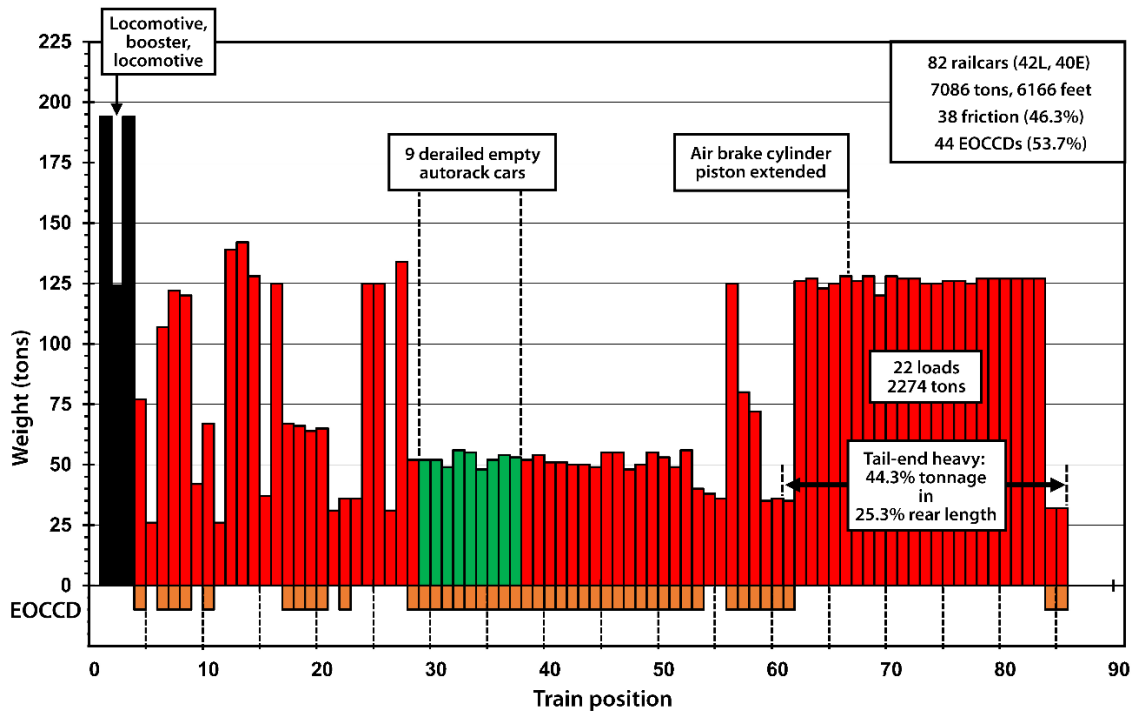
Figure 15. Assignment tonnage profile (Source: TSB)

Figure 15 also illustrates how each of the 3 cuts of cars were positioned and identifies the cars equipped with EOCCDs and standard friction draft gears. In particular, the cut of heavy cars added to the rear of the assignment also contained the car in the 63rd position that was observed to have its air brake cylinder piston extended.
