Transportation
Safety Board
of Canada

RAIL TRANSPORTATION SAFETY INVESTIGATION REPORT R19W0002

MAIN-TRACK TRAIN COLLISION AND DERAILMENT

Canadian National Railway Company
Freight trains M31851-01 and M31541-03
Mile 50.37, Rivers Subdivision
Portage la Prairie, Manitoba
03 January 2019

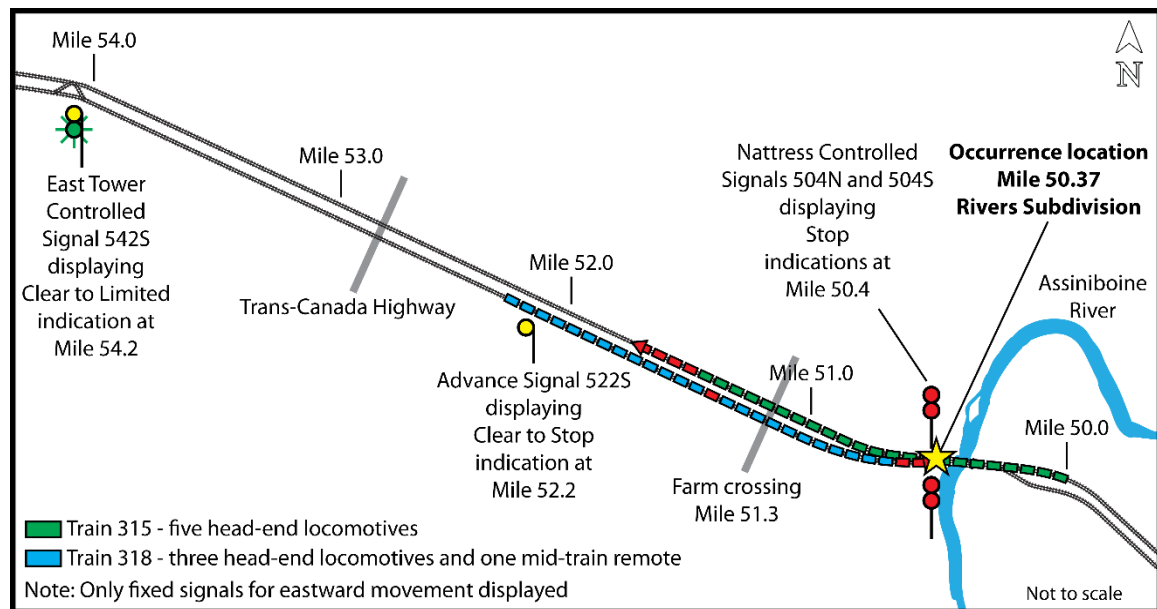
Figure S1. Progression of signals encountered by train 318 while approaching Nattress (Source: TSB)

Train 318 side-collided with train 315 while travelling at 23 mph (Figure S1). Shortly thereafter, the train 318 crew members jumped from the locomotive to the south side of the track and sustained minor injuries.

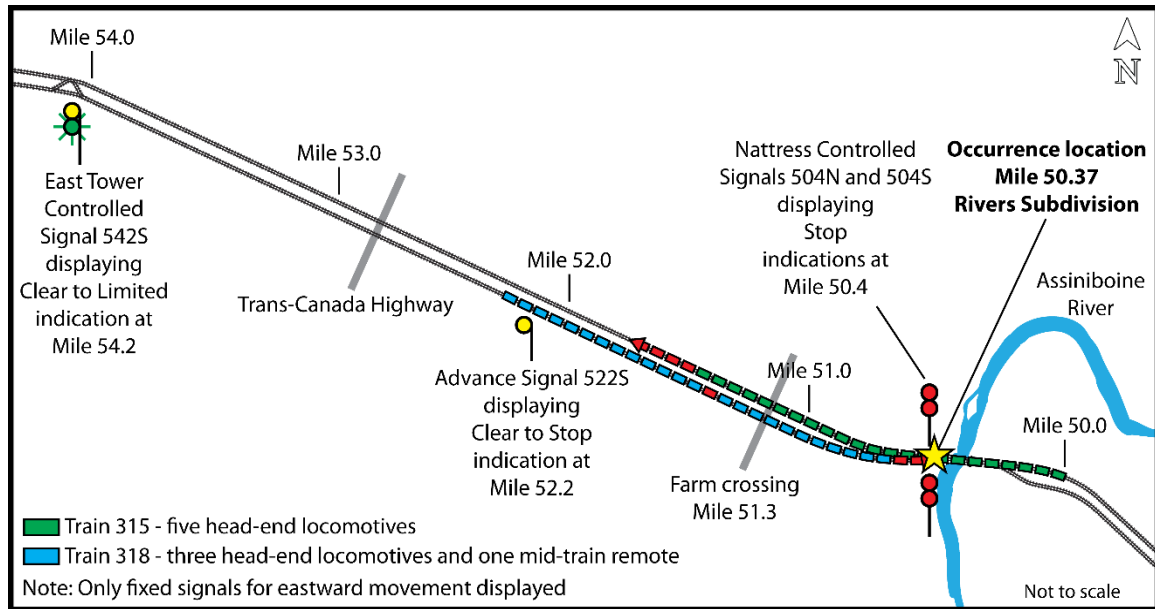
Figure 2. Progression of signals encountered by train 318 while approaching Nattress (Source: TSB)

At about 0906, while at the Mile 52.89 crossing, the train 318 conductor observed Advance Signal 522S (Mile 52.2), which was the next signal in the progression. Signal 522S displayed a Clear to Stop indication.²⁴ The conductor called out the Clear to Stop indication displayed

At 0908:22, the head-end locomotives of both train 318 and train 315 passed each other at Mile 51.13, just past a private farm crossing located at Mile 51.3. As this occurred, the train 315 crew noted that train 318 was approaching at a higher than expected speed. At about the same time, the train 318 conductor reminded the LE that they were proceeding on a Clear to Stop indication. The LE initially seemed unresponsive but then appeared to regain awareness. The LE had no recollection of the conductor calling the Clear to Stop signal in the cab nor of the events that subsequently transpired until the conductor reminded him that they were proceeding on a Clear to Stop indication. At that time, the train 318 TO remained engaged, the throttle was in position 6, the air brake pipe pressure was 89 psi, and the headlight remained off.

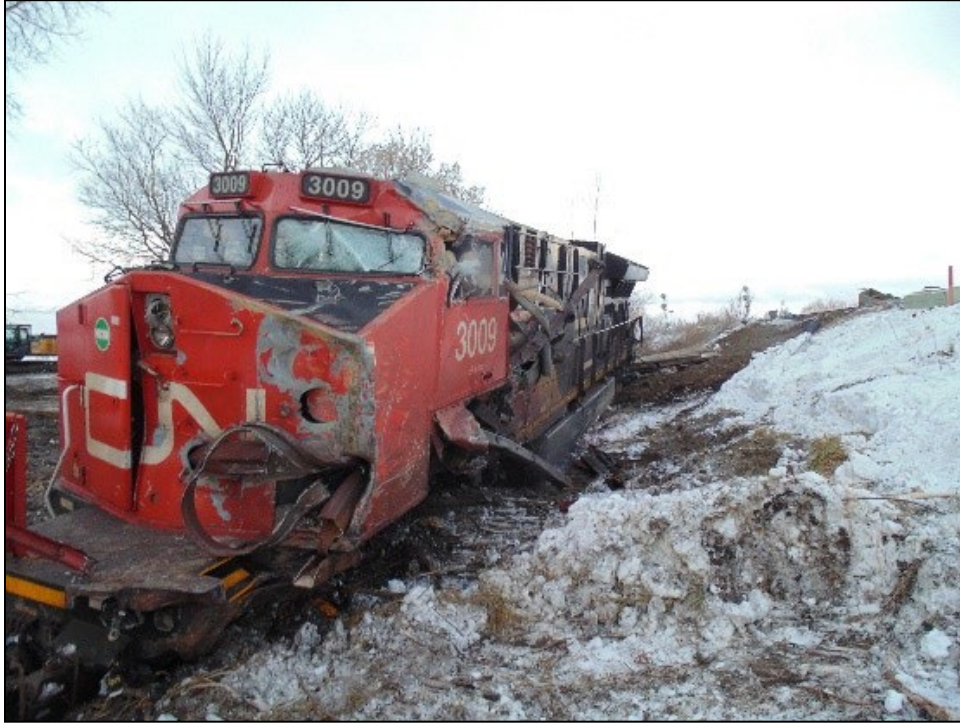
Figure 3. Damage to the north side of lead locomotive CN 3009 on train 318 (Source: TSB)

The 2 lead head-end locomotives on train 318 (CN 3009 and GECX 7371) both remained mainly upright but had derailed all wheels. The lead locomotive (CN 3009) came to rest at about a 45-degree angle from the track, partway down the south embankment. The north side of both locomotives had sustained damage. Lead locomotive CN 3009 was extensively damaged (Figure 3) while GECX 7371 exhibited some impact damage and scrapes. The fuel tanks on both locomotives were punctured, which resulted in the loss of a combined total of about 3500 imperial gallons (15 911 litres) of diesel fuel. The fuel was contained locally during site remediation and was subsequently cleaned up. No waterways were affected.

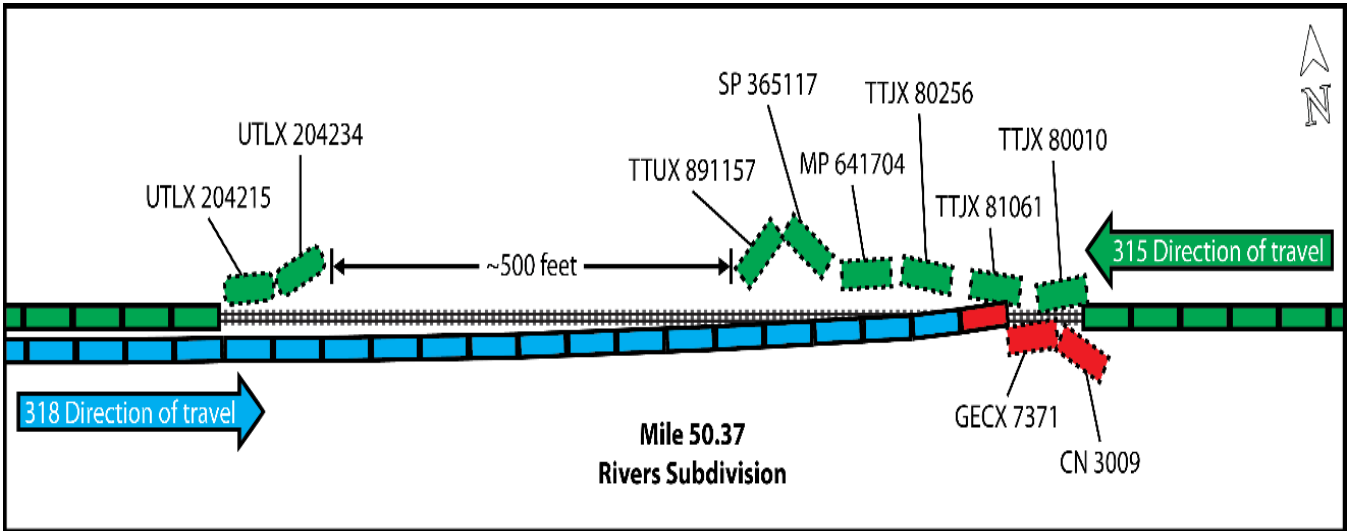
Figure 4. Site diagram (Source: TSB)

On train 315, the 95th to 102nd cars (inclusive) behind the head-end locomotives were derailed. The 95th and 102nd cars remained upright while the 96th to 101st cars were derailed onto their side (Figure 4). All train 315 derailed cars displayed various forms of impact damage sustained during the accident. Two empty non-DG Class DOT 111 tank cars were located in the 95th and 96th positions (UTLX 204215 and UTLX 204234). The south side of the 95th car tank shell was punctured, and the 96th car was derailed onto its side but was not punctured. Although it is not unusual for empty tank cars to have residue product remaining inside, no product was released during the accident.

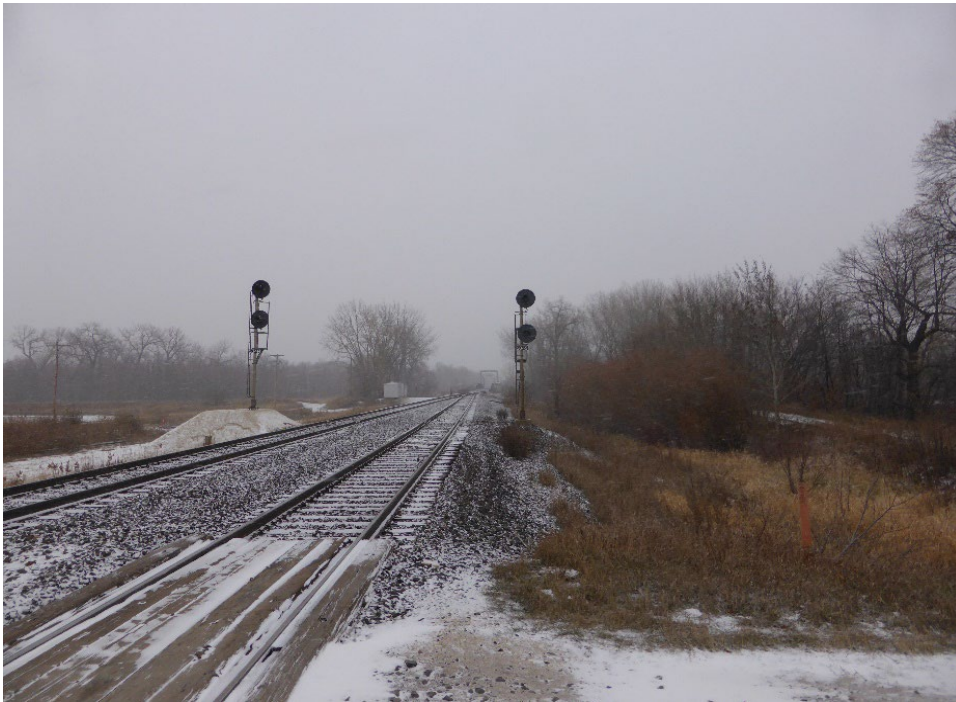
Figure 7. View looking eastward of signals 504S and 504N at Nattress (Source: TSB)

The signals stand about 15 feet higher than the surrounding area and are designed to be relatively eye-level for an approaching eastbound train crew when the approach to the signal is unobstructed. A dark backing or target is located behind the signal aspect to aid signal indication visibility in bright ambient lighting conditions.

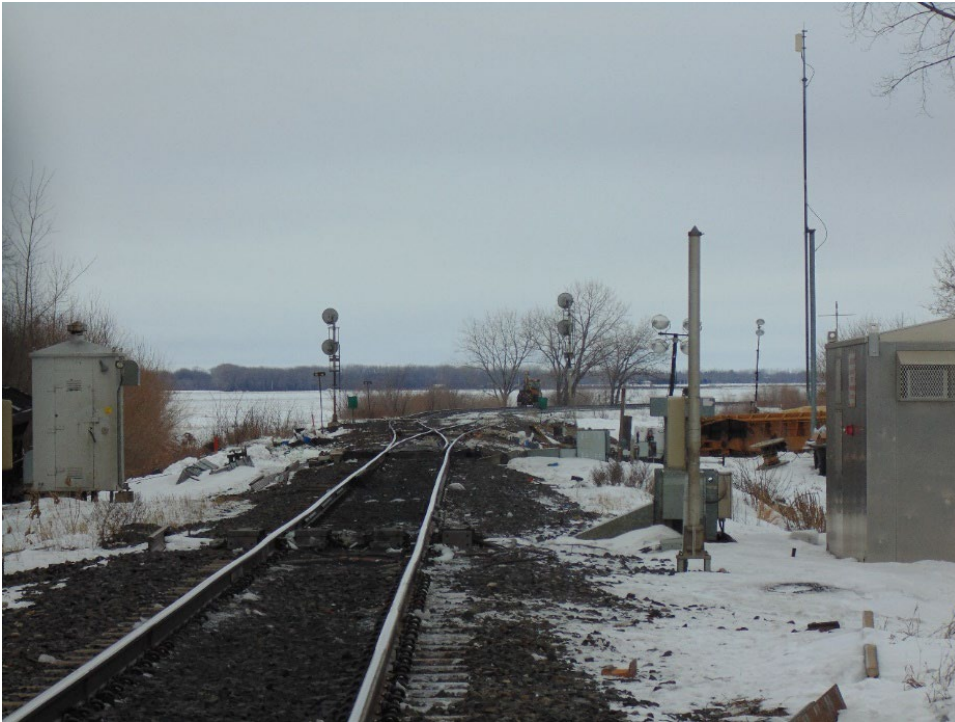
Figure 8. View looking westward of signals 504S and 504N at Nattress showing the transition from double to single main track (Source: TSB)

From about Mile 50.84 to Mile 50.51 (approximately 1700 feet), the track curves to the left (in the direction of travel for train 318) as the track nears the equilateral turnout at Nattress (Mile 50.37). For an eastbound train operating on the south main track with an unobstructed view, the signal indications at Signal 504S (Mile 50.4) are normally visible from an estimated 1600 feet to the west (Mile 50.7). Beyond 1600 feet, the signals become obscured by brush and foliage along the railway right-of-way.

When the adjacent north track is occupied by a train, the combination of the adjacent train and track curvature obscures the signal indications at Signal 504S (Mile 50.4) up to an estimated 900 feet to the west (Mile 50.57).
