National Transportation Safety Board

Safety Recommendation Report

Placement of DOT-111 Tank Cars in High Hazard Flammable Trains and the Use of Buffer Cars for the Protection of Train Crews

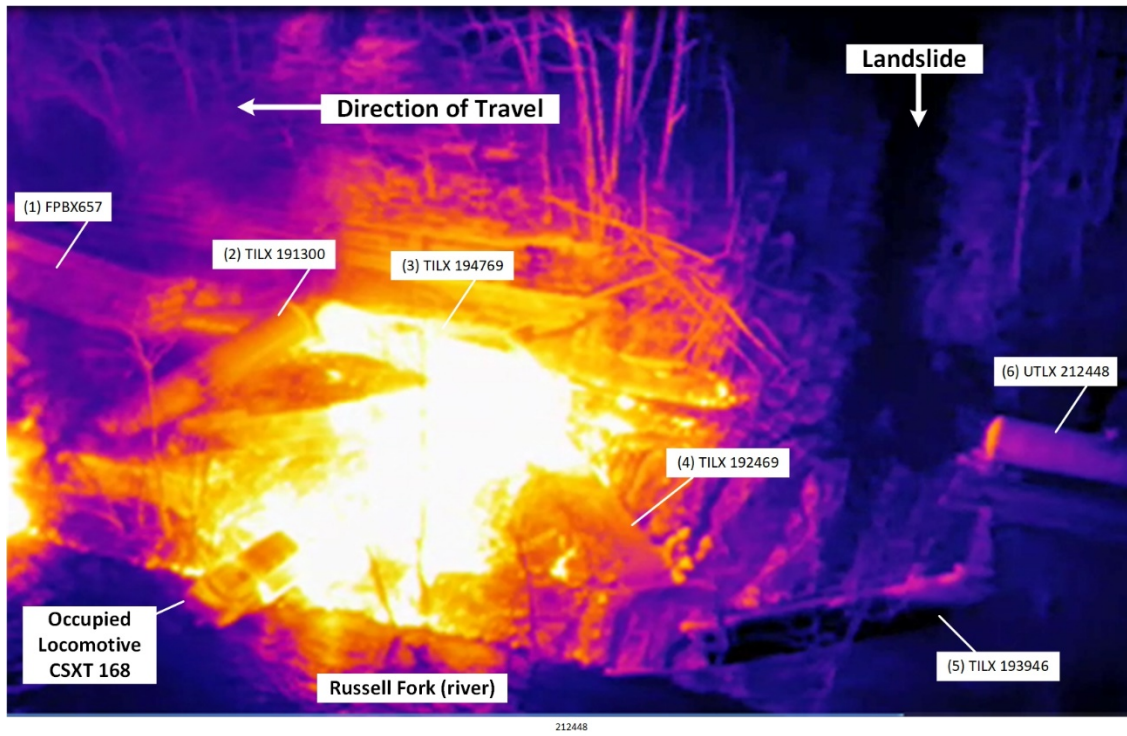
Figure 4. Draffin, Kentucky, derailment scene thermal image. (Courtesy of Pike County, Kentucky, Emergency Management Agency.)

The Pike County deputy emergency management director told NTSB investigators that firefighters observed the train crew grasping to the front of the lead locomotive while a large fire burned near them. He said the cab of the locomotive was engulfed in flames that came within 10 feet of the crew. The deputy emergency management director stated, “the fire was right at them and they appeared to be panicking ... their choices were to go toward the fire or jump into the river.” The train crew entered the water and was ultimately rescued by emergency responders.

The first derailed tank car in the consist was a specification DOT-117R, TILX191300, which sustained a severe angular dent to its leading head, most likely during impact with one of the derailed locomotives as the tank car was pushed forward by trailing tonnage. The ability of the first tank car to retain all its lading was due in large part to it being equipped with a head shield. However, the second and third tank cars, both legacy specification DOT-111 tank cars, were not so equipped. The second tank car, TILX 194769, was punctured in its unprotected leading head and right-side tank shell after experiencing similar derailment impact conditions, and it released its entire load of denatured ethanol to form a pool fire. The unprotected leading head of the third DOT-111 tank car, TILX192469, was punctured when it impacted the third locomotive’s front platform or pilot structure.²⁴ The pool fire engulfed all three locomotives, including the lead locomotive cab, which was destroyed by the fire. As evident from this accident sequence, the lack of sufficient separation distance between the lead locomotive and DOT-111 ethanol tank cars placed the train crew at risk of death or serious injury from the hazardous materials release.
