Passenger Fatality

Massachusetts Bay Transportation Authority

Boston, Massachusetts
April 10, 2022

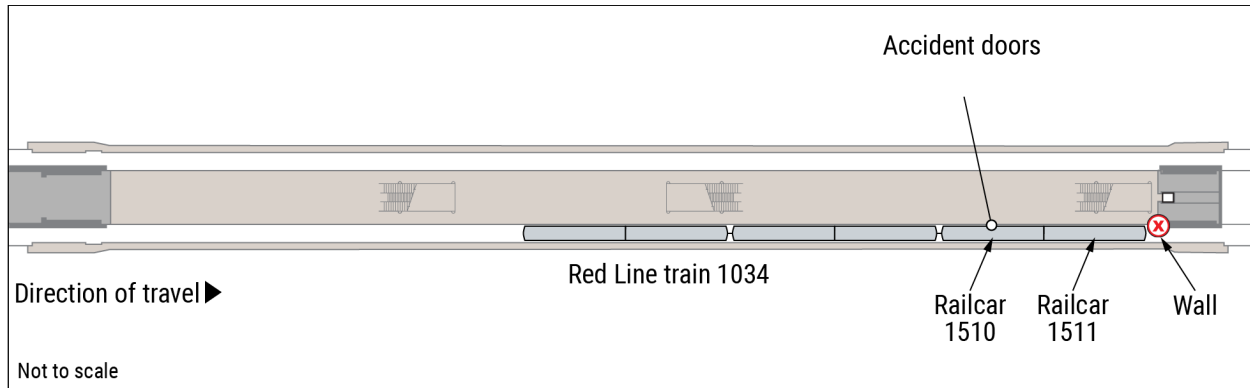
Figure 1. Diagram of the Broadway Station platform.

On April 10, 2022, about 12:30 a.m. local time, a Massachusetts Bay Transportation Authority (MBTA) passenger was dragged and killed as northbound MBTA Red Line train 1034 departed Broadway Station in Boston, Massachusetts.¹ About 12:29 a.m., train 1034 arrived at Broadway Station, and the accident passenger and several others boarded the train. Station surveillance video reviewed by National Transportation Safety Board (NTSB) investigators showed that, as the train was departing, the accident passenger attempted to exit the train using the middle passenger doors of railcar 1510, the second railcar of the six-car train. According to the video, the doors closed on the accident passenger’s upper body on his right side as he stepped back onto the platform. As the train accelerated to depart the station, the passenger ran alongside the train with his upper body pinched between the doors. The train did not stop, and the passenger collided with a wall at the end of the platform and was killed. Figure 1 provides a diagram of the accident location.

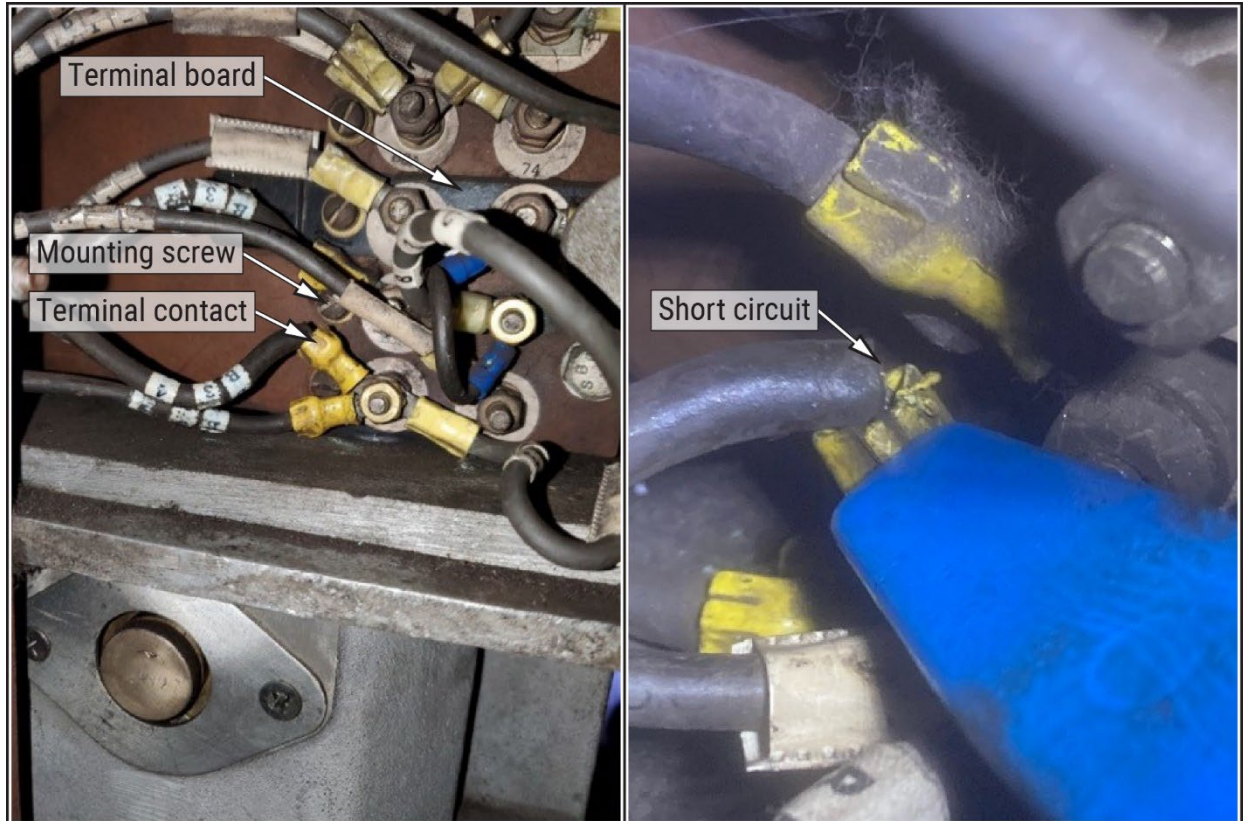
On April 11, 2022, on MBTA property, NTSB investigators tested the propulsion system on train 1034 and observed that trainline propulsion was enabled even if the passenger door interlock circuit was open (that is, if there was an open door). Further testing of each railcar in train 1034 showed that a short circuit in railcar 1511 bypassed the functionality of the passenger door interlock circuit.⁷ A review of the passenger door interlock circuit schematics indicated the short circuit was located in the electromechanical contact connections, specifically the terminal contacts and finger contacts located on the wire terminal board under the Cineston master controller in railcar 1511.⁸

NTSB investigators then examined the Cineston master controller and observed wire strands protruding from the terminal contact of one of the wires. These protruding wire strands were touching a mounting screw close to the contact, completing the short circuit. (See figure 2.)

Figure 2. View (*left*) and close-up (*right*) of the short circuit.

In this accident, an MBTA passenger was dragged and killed when the passenger doors of railcar 1510 of MBTA Red Line train 1034 closed on his upper body and the train departed Boston's Broadway Station. Postaccident examinations and testing found a short circuit in the electromechanical contact connections under the Cineston master controller in the lead railcar.

NTSB investigators determined that the short circuit bypassing the passenger door interlock circuit occurred sometime after the 2017 Cineston master controller rebuild. As a result of the accident, MBTA implemented a method to electrically isolate wire terminal contacts and mounting screws on the Cineston terminal board and updated its door obstruction and door interlock testing procedures. The FTA assumed an increased safety oversight role of the MBTA system and began conducting safety management inspections of MBTA transit operations and maintenance programs.

The National Transportation Safety Board determines that the probable cause of the April 10, 2022, passenger fatality was a short circuit in the passenger door interlock circuit on the accident railcar that enabled propulsion on train 1034 with the door obstructed by a passenger, causing the passenger to be dragged along the platform.

MBTA implemented a method of electrical isolation between wire terminal contacts and mounting screws on the Cineston terminal board so that protruding wires do not unintentionally complete a short circuit.
