Railroad Investigation Report RIR-23-08

Derailment of Amtrak Passenger Train 7 on BNSF Railway Track

Joplin, Montana
September 25, 2021

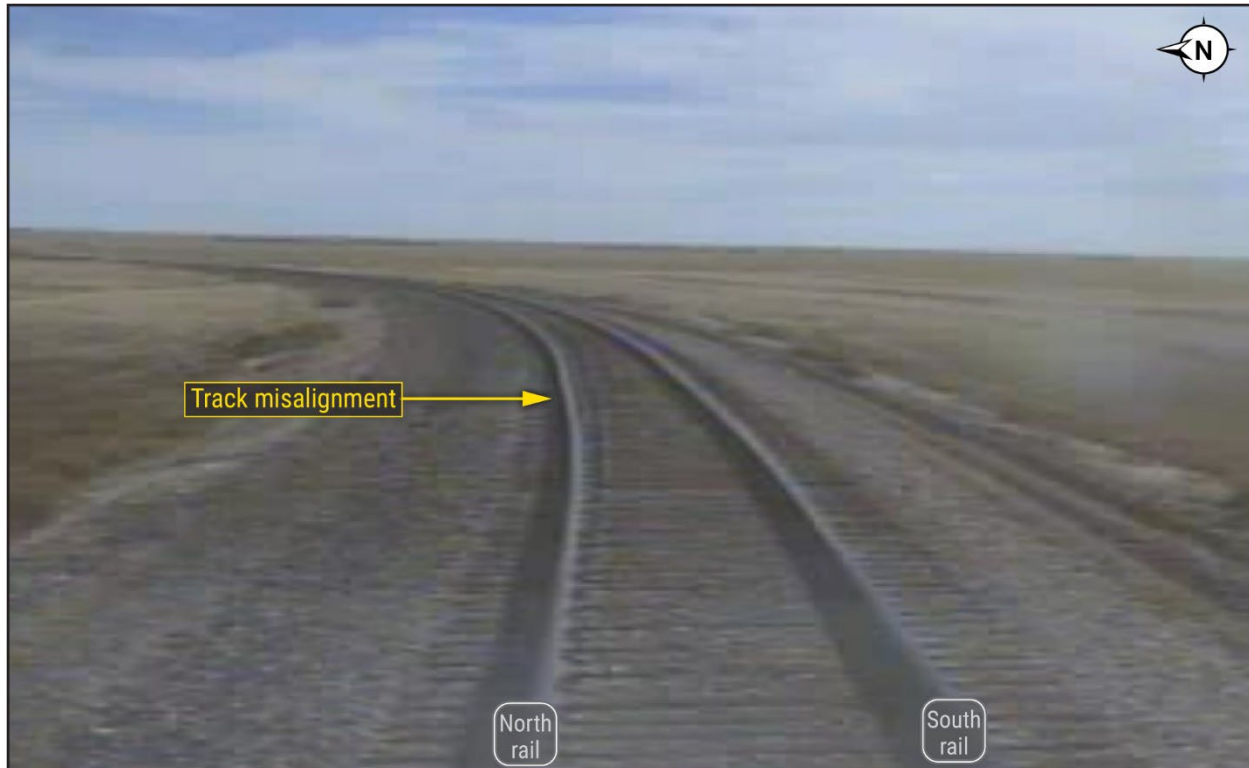
MP 1014.55. (See figure 4.) The north-side running rail (north rail), the inside rail of the curve, in the still image is laterally shifted toward the left.¹²

Figure 4. Still frame from Amtrak Train 8 that shows the misaligned BNSF track.

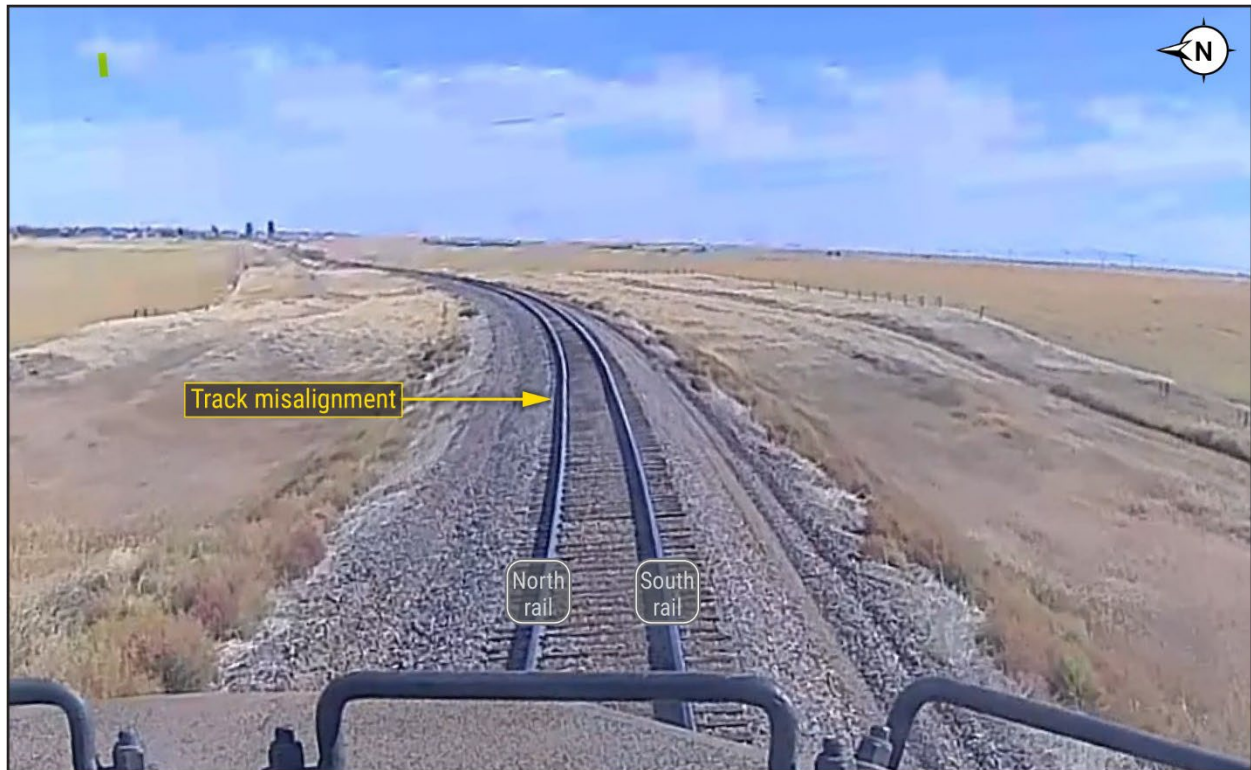
At 1:31 p.m., eastbound BNSF freight train 4182-ZSSECHC7-24A, traveling about 61 mph, traversed through the misaligned BNSF track about 2 hours 25 minutes before the derailment of Amtrak Train 7. Forward-facing image recordings show significant right and left rolling, yawing, and swaying of the train as it traveled over the misaligned BNSF track. A still image was captured from the recording and shows the misaligned BNSF track in the curve at MP 1014.55. (See figure 5.) Both the north rail and south rail are shown to be laterally shifted toward the left.¹³

Figure 5. Still frame from BNSF freight train 4182-ZSSECH-24A that shows the misaligned BNSF track.

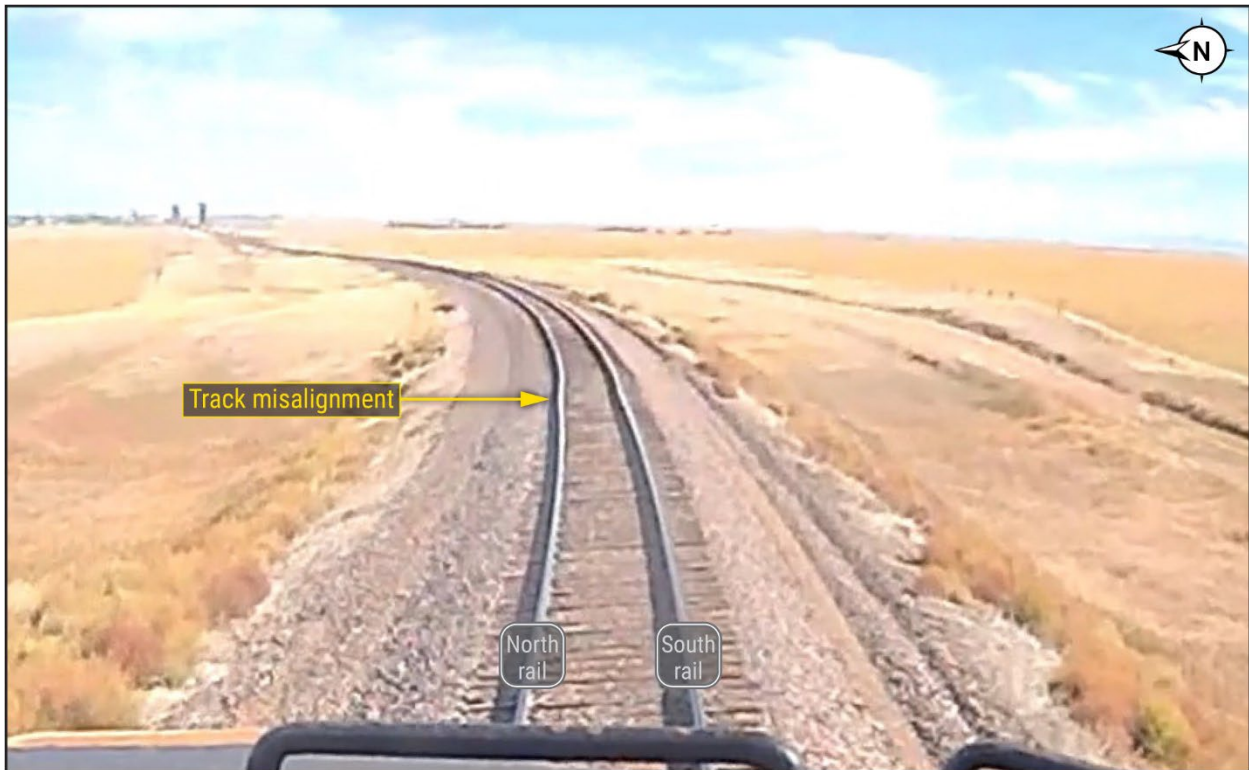
At 1:42 p.m., eastbound BNSF freight train 7380-QPTLCHC3-23A, traveling about 47 mph, traversed through the misaligned BNSF track about 2 hours 14 minutes before Amtrak Train 7. Forward-facing image recordings show significant right and left rolling and swaying of the train as it traveled over the misaligned BNSF track. A still image from the recording shows the misaligned BNSF track in the curve at MP 1014.55 immediately before the train traveled over the misalignment. (See figure 6.) Both rails are shown to be laterally shifted toward the left.

Figure 6. Still frame from BNSF freight train 7380-OPTLCHC3-23A that shows the misaligned BNSF track.

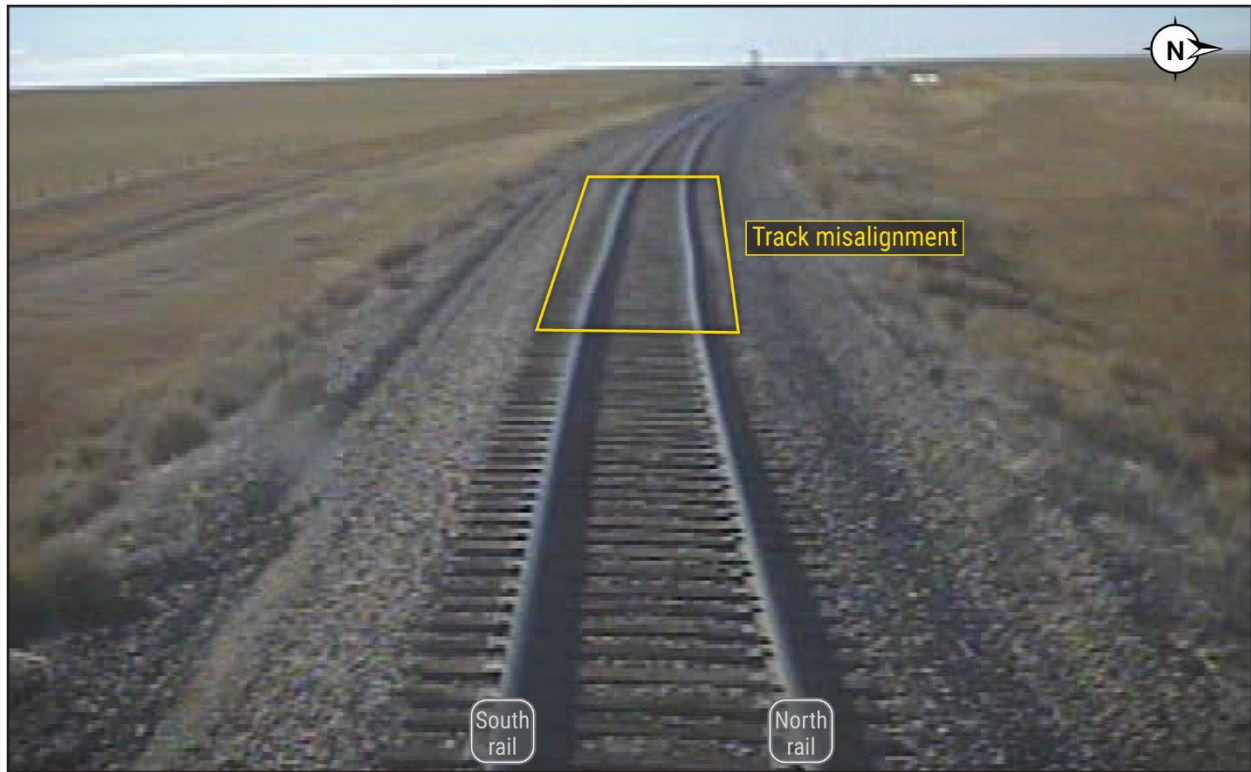
The forward-facing image recording from Amtrak Train 7 shows about 2.9 inches of lateral movement of the rails about 1 second before the derailment. (See figure 7.) The recording shows the locomotive undergoing a short-duration roll.¹⁴

Figure 7. Still frame from Amtrak Train 7 that shows the misaligned BNSF track.

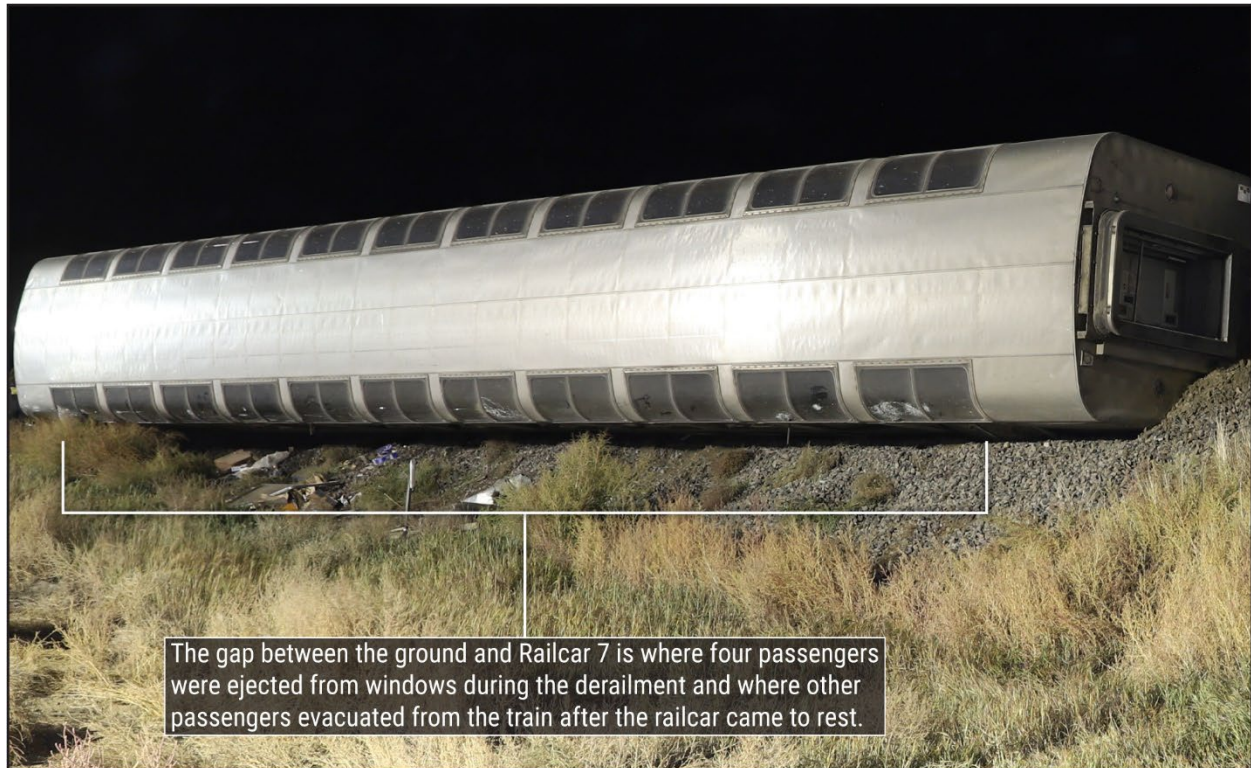
rode on top of the glass; however, the window gave way as the train slowed to a stop, falling out of its frame and dropping the couple to the ground. Railcar 7 came to rest on its side with a gap between the side of the railcar and the ground. Figure 8 shows Railcar 7 in its resting position.

Figure 8. Photograph of overturned Railcar 7 in its position after the derailment.

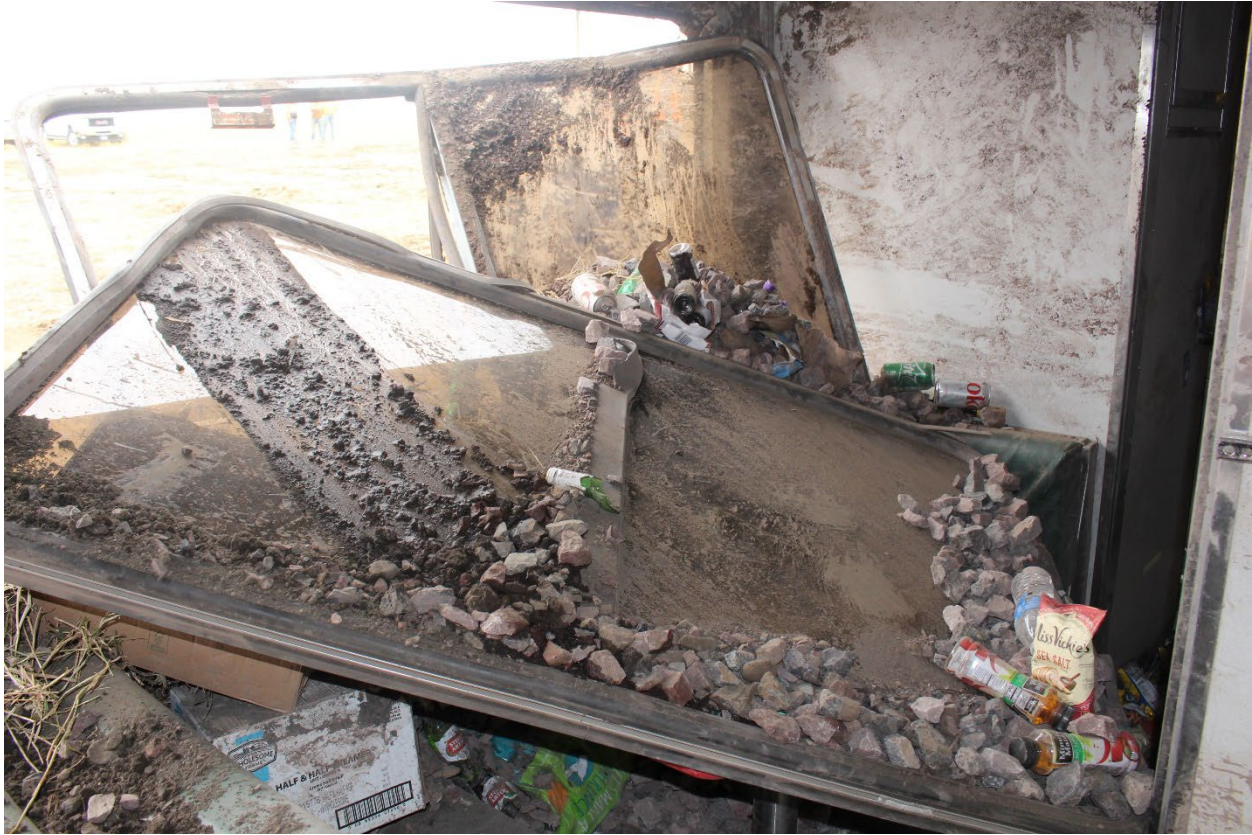
38.12 inches high. The actual frame opening of these windows is about an inch smaller. Figure 9 shows a damaged window from Railcar 7.

Figure 9. Postderailment photograph of a damaged window from Railcar 7.

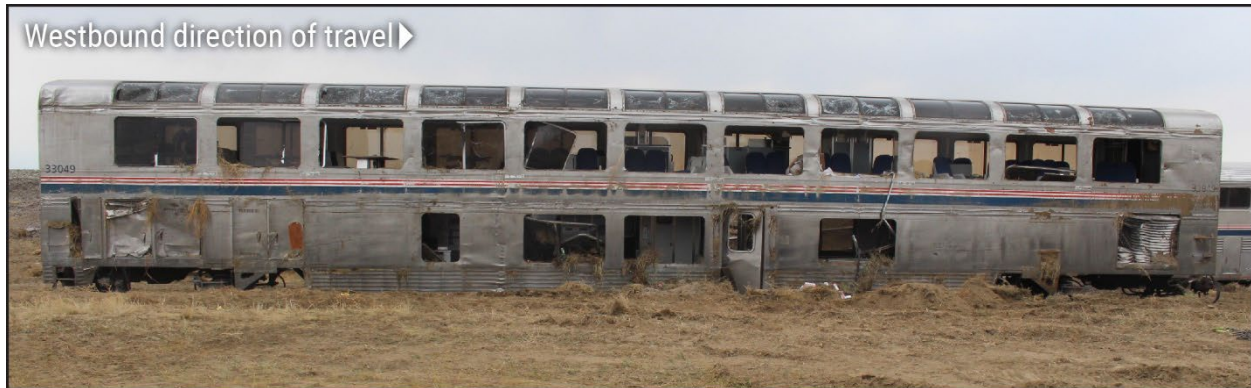
Figure 10 shows the exterior right side of Railcar 7 after it had been righted at the scene. The occupant ejections occurred from the missing windows on the upper level.

Figure 10. Photograph of the exterior of Railcar 7.

In this derailment, multiple window systems in Railcars 7 through 10 failed. As noted previously, the rear four railcars overturned onto their sides during the derailment. The failure of the window retention system resulted in the loss or displacement of 47 windows in the four overturned railcars. (See table 5.)

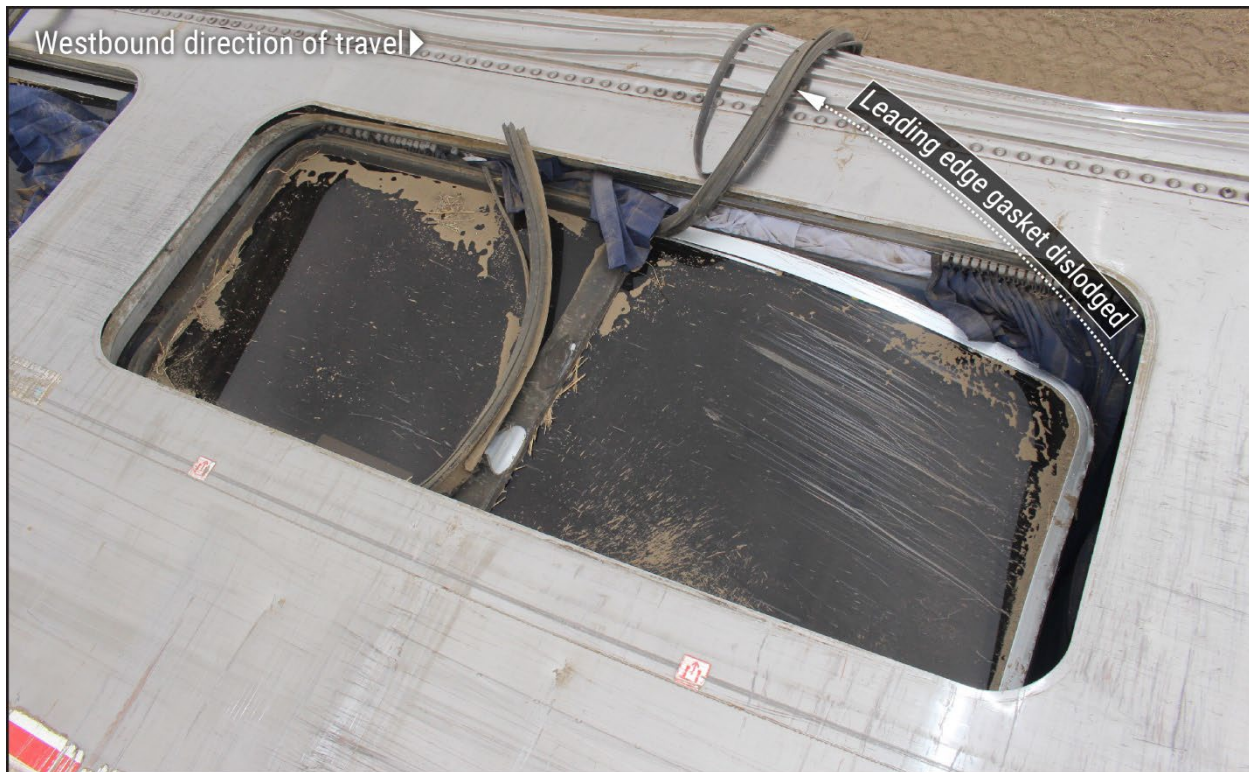
The gaskets were torn away from the windows as the railcars slid across the ground. (See figure 11.) The windows either detached entirely or became partially dislodged, which allowed dirt and ballast to push into the void spaces and fill the occupied spaces within the railcar.

Figure 11. Exterior photograph of a window from Railcar 9.

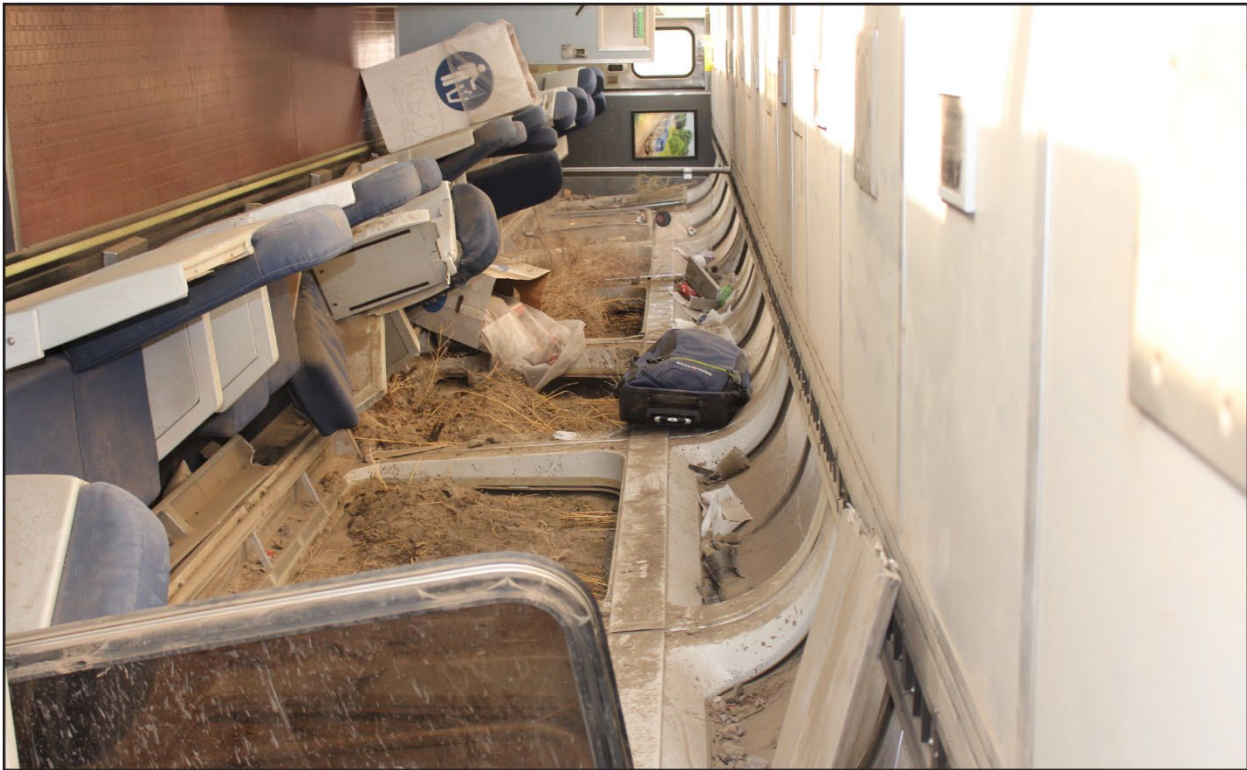
Railcar 7 derailed onto its right side and exhibited extensive damage to the exterior sidewall, which included 9 of 11 large, side passenger windows that were missing or dislodged. Figure 12 shows the interior of Railcar 7 after the derailment.

Figure 12. Interior of Railcar 7 after the derailment.

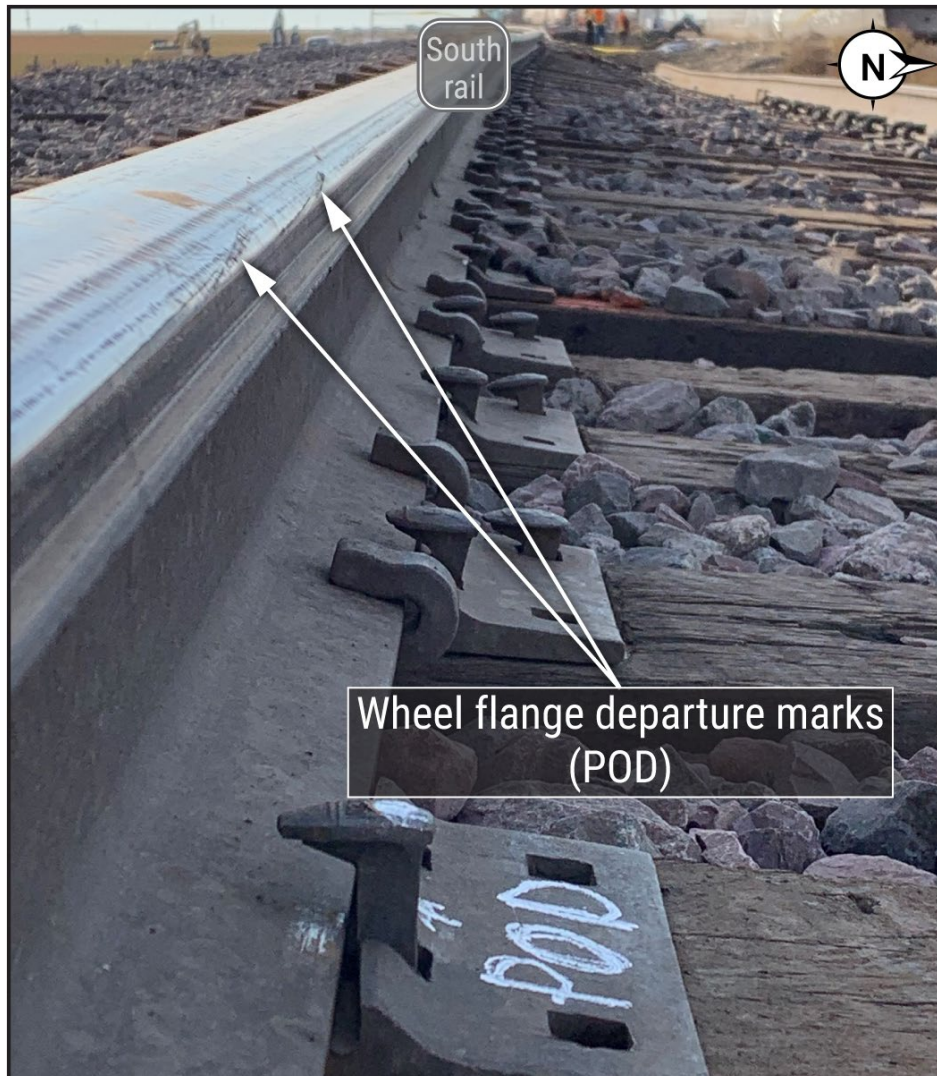
Amtrak Train 7 derailed at MP 1014.57. The NTSB observed the first wheel flange departure marks in a curve on the south rail, about 100 feet west of the bolted replacement rail.²⁴ The wheel flange departure marks were about 2 inches apart, beginning at the gauge corner of the south rail.²⁵ The wheel flange departure marks traversed up and across the head portion of the south rail.²⁶ The markings did not fully extend across the entire rail head portion of the running rail. There were no other derailment witness markings between the misaligned BNSF track and the confirmed POD. Figure 13 shows the first wheel flange departure marks at the POD in a curve on the south rail.

Figure 13. Wheel flange departure marks on the south rail.

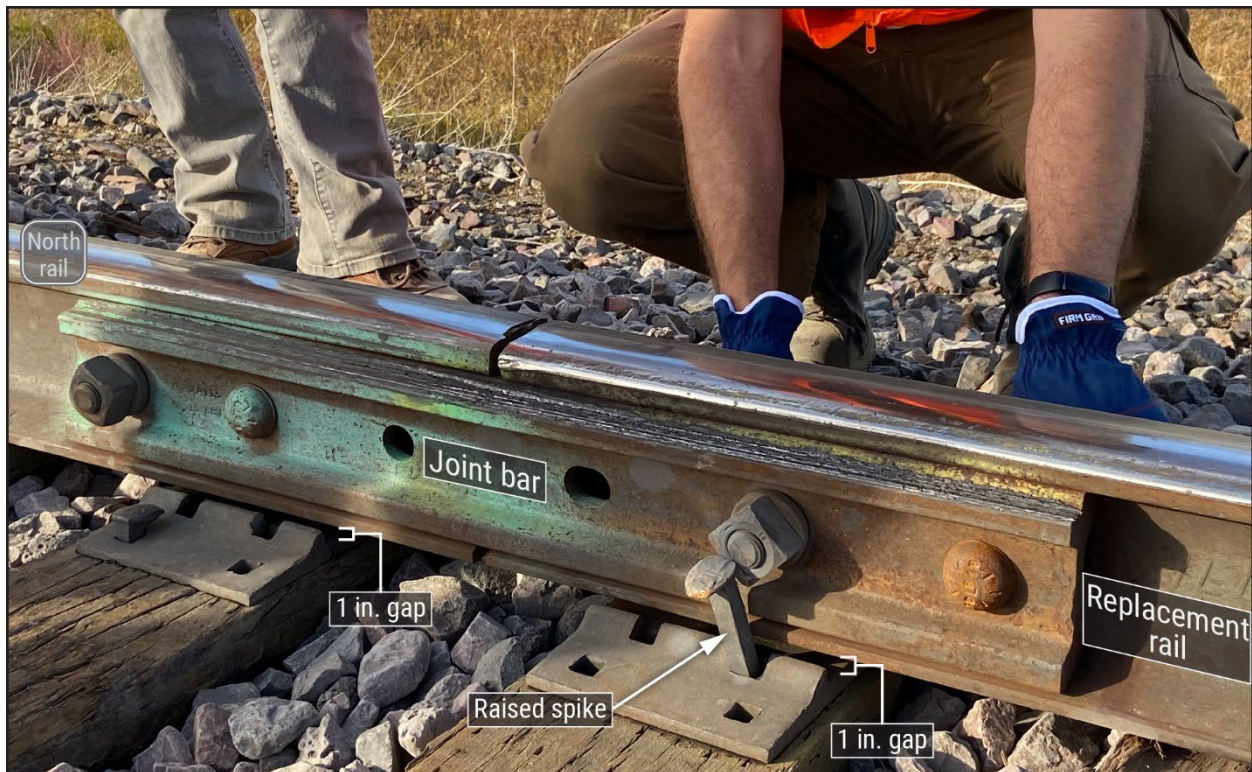
Replacement rails or plug rails are sections of rail connected at each end to the existing CWR using bolts and metal bars known as joint bars. Amtrak Train 7 derailed about 100 feet beyond the west joint of two four-bolt rail joints between MP 1014.55 and MP 1014.57. BNSF requires that replacement rails be 18 feet or longer in that area of curved CWR track. Policy set forth in BNSF's *Engineering Instructions* state that temporary rail joints left in place up to and including 90 days need to be inspected quarterly (BNSF 2021). Figure 14 shows an example of a bolted replacement rail. The rail spike is raised in the photograph because of the contact with the joint bar. As the rail and joint bar move vertically under the load of the train, the spike is gradually worked out of the crosstie. This is known as vertical track deflection, which will be discussed further in section 1.9.3.2. The anchor spike (the spike that is not in contact with the joint bar) moves along with the crosstie and is not influenced by the rail/joint bar movement.

Figure 14. Photograph of a bolted replacement rail.

During the postderailment inspection of the BNSF track, the NTSB noted a 19 feet 6 inches bolted replacement rail with two four-bolt rail joints between MP 1014.554 and MP 1014.550, 100 feet east of the POD. The replacement rail was installed using standard six-hole joint bars on each end. Each joint bar was secured with two bolts at each rail end using 6.5-inch standard bolts, nuts, and locking washers securing the joint bars. BNSF records indicate that this rail was installed on July 23, 2021, 64 days before the derailment. The four-bolt rail joint in the area of this derailment was considered maintenance rail, not installation rail. Maintenance rail is used to replace rail determined to be defective. It is a shorter rail section that is cut into larger sections of preexisting CWR when a track defect requires that the rail be replaced.

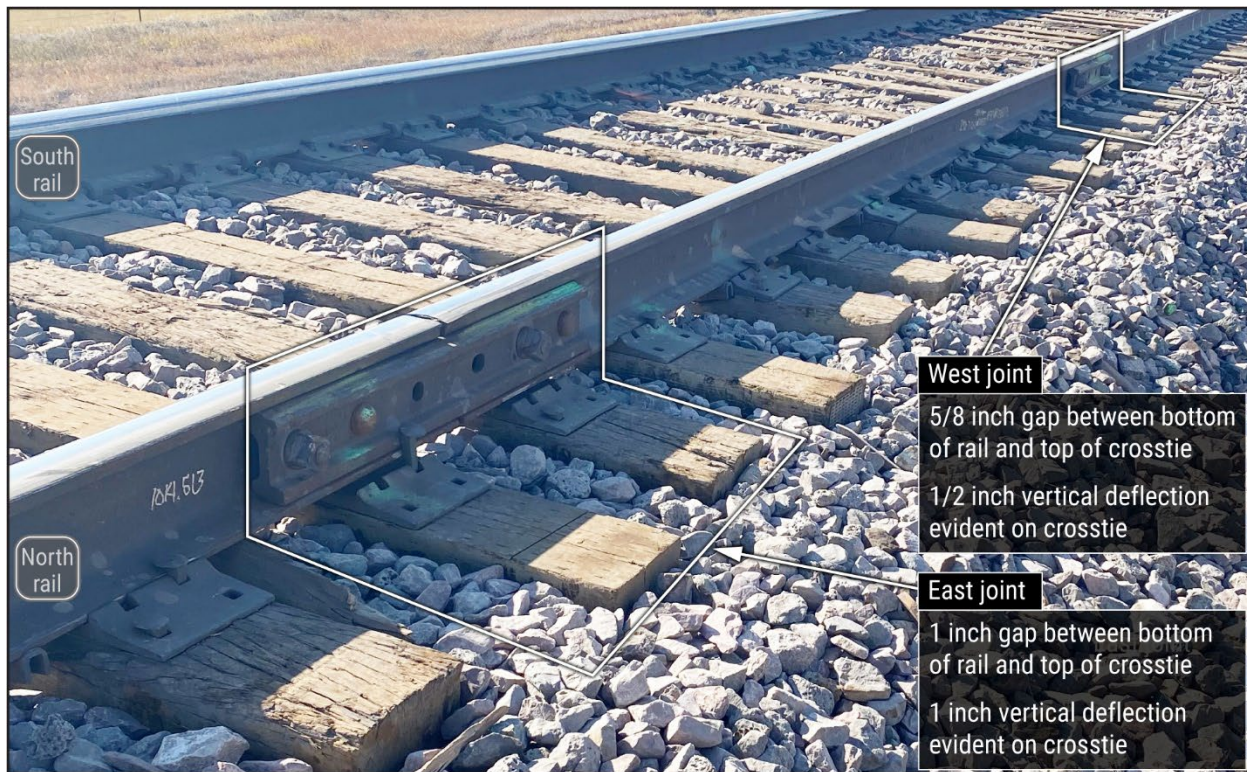
Since Amtrak Train 7 was traveling west, it encountered the east joint first. During the investigation, the NTSB observed that the east joint of the bolted replacement rail had a vertical gap of about 1 inch between the rail base and the crosstie plates. There was also visible evidence of an additional 1 inch of vertical track deflection of the crosstie that would have occurred when a train was traversing/loading the rail, resulting in a vertical track deflection totaling about 2 inches.³⁰ The west joint of the bolted replacement rail had a gap of 5/8 inch between the rail base and the crosstie plate with an additional 1/2 inch of vertical track deflection noted, totaling about 1 1/8 inch. (See figure 15.) Title 49 *CFR* 213.13 "Track Safety Standards" states that when unloaded track is measured to determine compliance with the requirements, the amount of (vertical) rail movement, if any, that occurs while the track is loaded must be added to the measurement of the unloaded track. This regulation is in place so that when track geometry is measured for the purpose of inspection, it is representative of the conditions that a train will encounter while traversing the track.

Figure 15. Vertical track deflection evidence at the derailment curve.

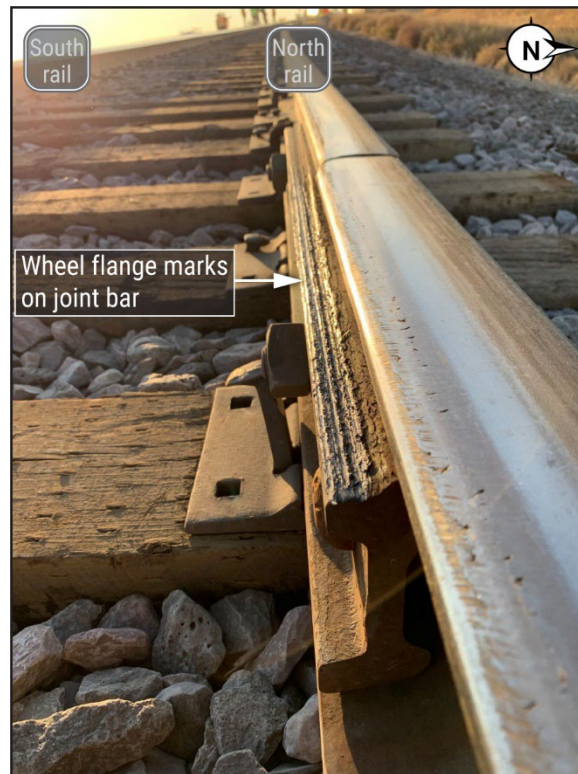
The NTSB noted that several replacement rails along the north side of the derailment curve had 1/2-inch vertical worn rail. Vertical worn rail is calculated as the difference when compared to a new rail section of the same weight or dimensions. As shown in figure 16, there are grooves and grease on the joint bar, which is consistent with wheel flange contact. This indicates the wheel's flange had made contact with the joint bar as it traveled over the worn rail, thus departing from the normal wheel-rail interface. As rail head wears, the clearance between the joint bar and a wheel's flange is reduced. If the wear is severe enough, then the wheel's flange will make contact with the joint bar, creating an unsafe condition.

Figure 16. Photograph showing a north four-bolt rail joint with wheel flange contact on the joint bar.

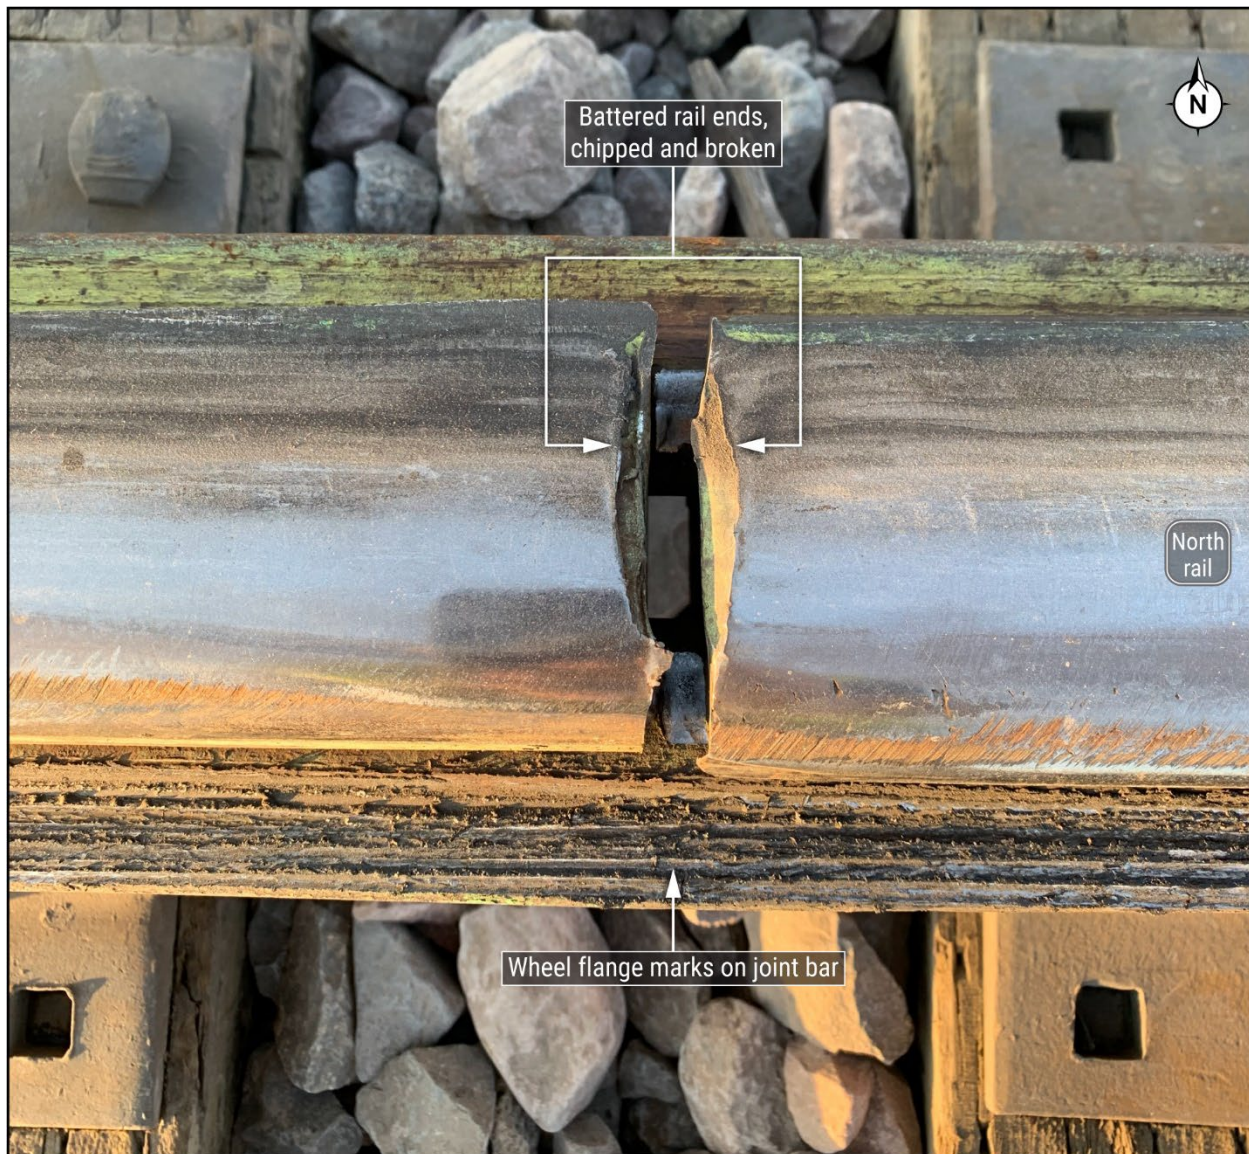
As illustrated in figure 17, the rail ends were chipped and broken, and there is evidence of wheel flange contact on the rail joint bar impacting the four-bolt rail joints.

Figure 17. Photograph of the four-bolt rail joint with wheel flange contact on the joint bar. The top of this photograph shows the battered rail ends.

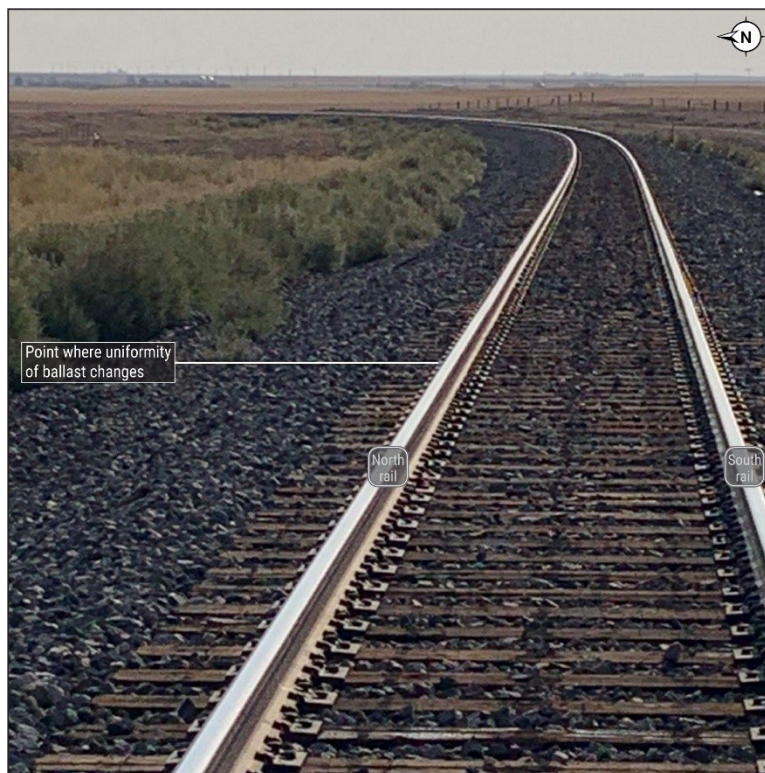
From the POD at MP 1014.57, the area of vertical moving track extended about 78 feet west and about 200 feet east. The NTSB observed this area exhibited abnormally disturbed ballast in the space between the crossties that was not uniform. In addition, the ballast surrounding the crossties showed evidence of movement which is an indication of vertical deflection of the track under loads imposed by the weight of trains.

Although there is always some vertical movement in track, the NTSB observed a freight train traversing the fill during the inspection and noted that the track was moving more significantly in a vertical direction under the loads put on the track by the train wheels than on the other areas of the track. (See figure 18.)

Figure 18. Photograph of the derailment curve.
