Subject: RRD23LR006- Springfield, OH- Safety Performance of Wheelsets Investigation Closeout Memo

RRD23LR006

SAFETY PERFORMANCE OF WHEELSETS

Specialist's Factual Report
September 21, 2023

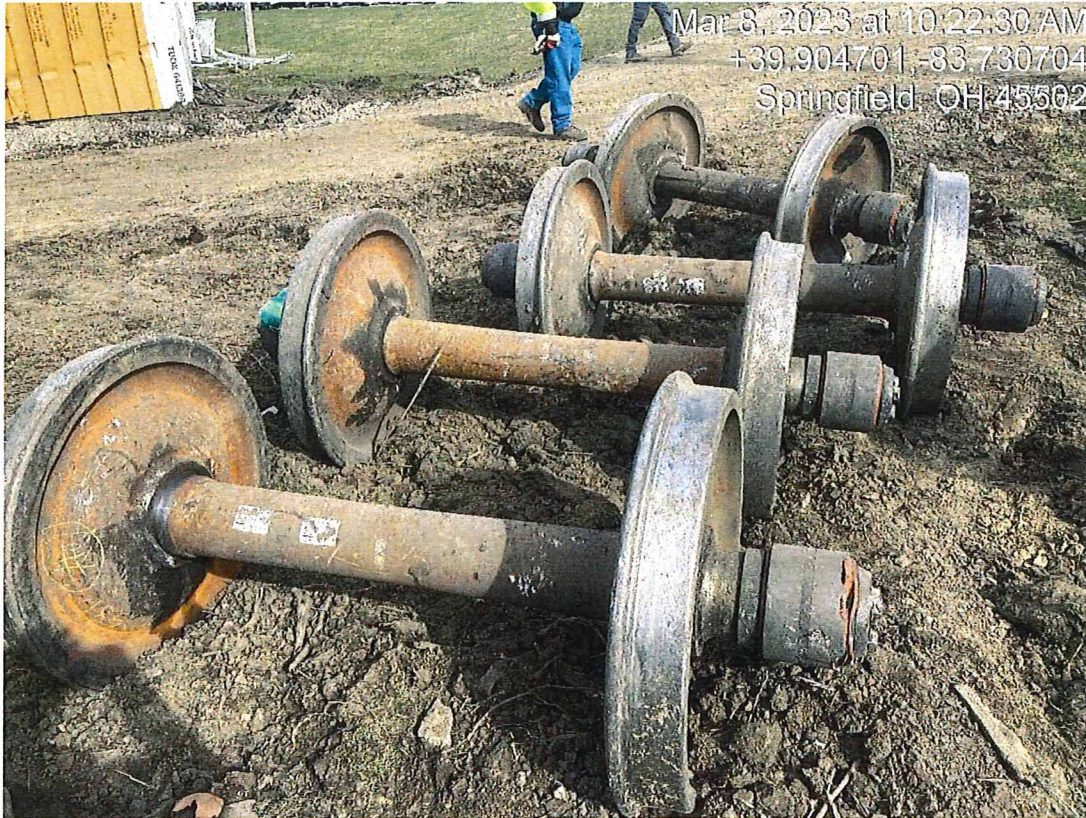
NTSB placed an investigative hold on twelve wheelsets from three cars of the derailed train. The wheels on three of the wheelsets had moved from their seats on their axles during the derailment. Each wheelset held by NTSB was mounted by National Steel Car around the same time as those exhibiting movement on their axles in the derailment.

Figure 1. Wheelsets from car NS 162581 held by NTSB for investigation at the derailment scene.

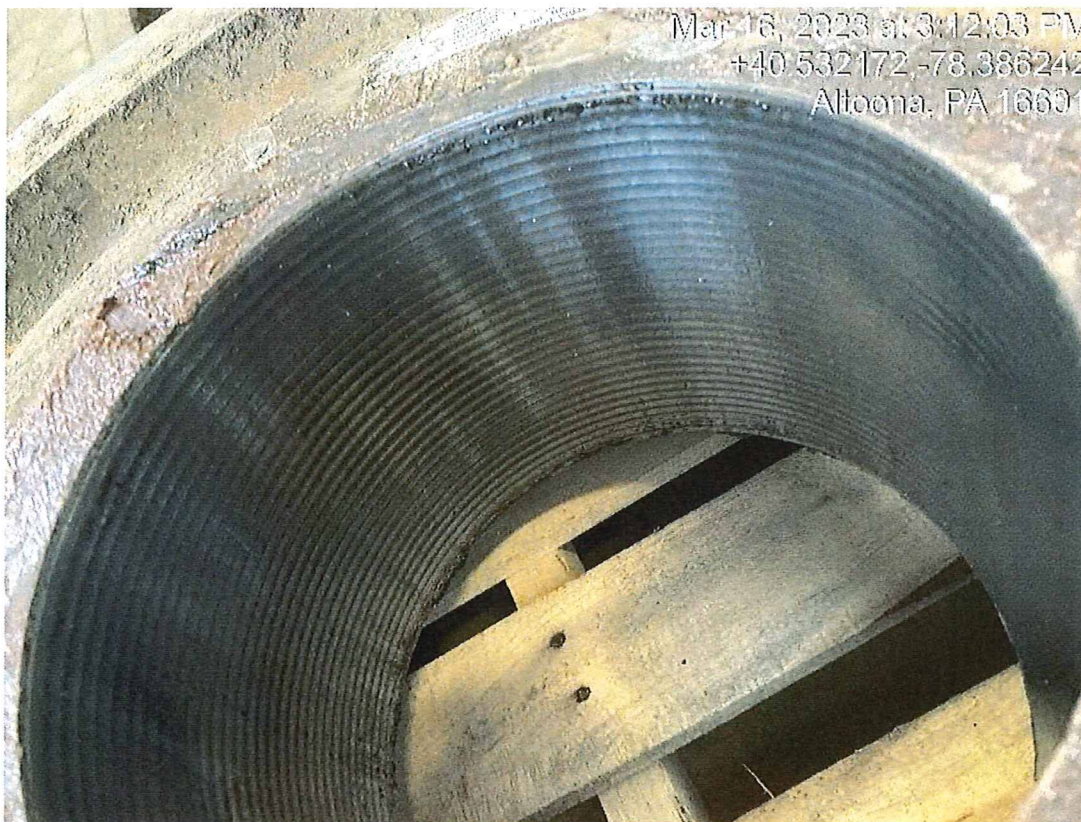
The axle containing wheel 05544 that was completely dislodged in the derailment was cut to remove the dislodged wheel. The mate wheel to wheel 05544 (wheel 05508) was pressed from the axle, and the wheel bore and axle seat of each wheel from that axle were visually examined for evidence of movement on the axle, along with conditions that could lead to such movement, such as fretting. No evidence of movement on the axle prior to the derailment was identified. The wheel bores for wheels with serial numbers 05523, 05987, 07084, 07340, and 05508 from cars NS 162581 and NS 162582 each contained between 31 and 32 machining grooves per bore.

Figure 2. Wheel bore of wheel 05508 from car NS 162581 after being pressed from its axle.

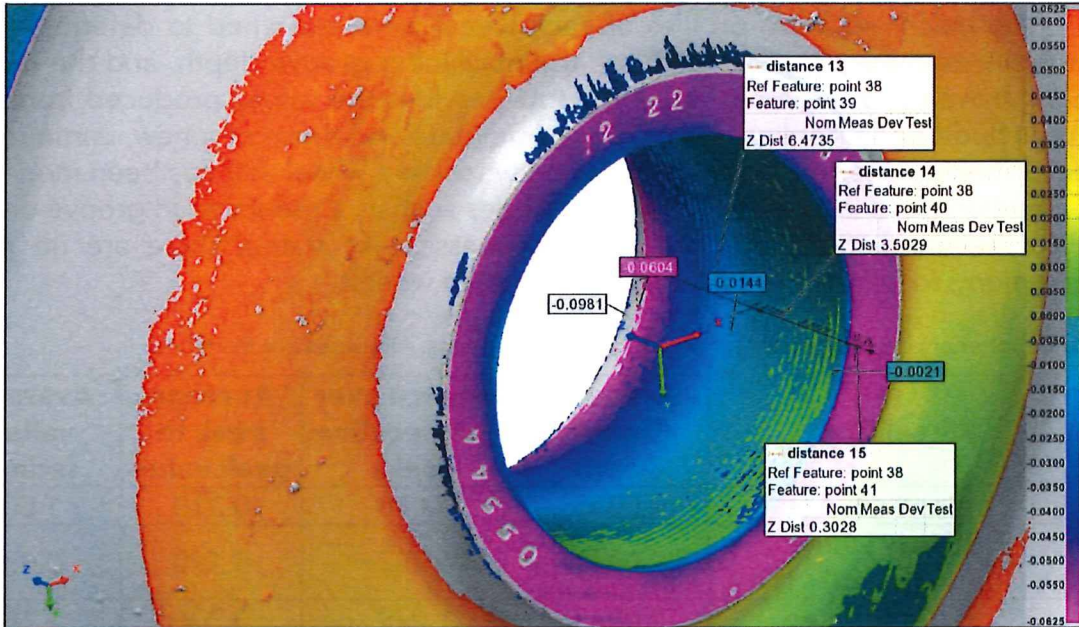
Wheel 05544, which moved off its seat in the derailment, showed asymmetric distortion of the wheel bore on the front side (outboard) and a smaller localized area of distortion on the inside (inboard), directly opposite. A similar pattern of distortion, though of a lesser magnitude than that present on wheel 05544, was present on the outboard front side of wheel 07340, which dislodged in the derailment.

Damage was noted on the rim of wheel 05544, opposite of the area of distortion in the wheel bore. Additionally, damage was present on the bearing end cap on the opposite end of the axle of dislodged wheel 05544.

Figure 3. Image generated during 3D scan of wheel 05544 showing the overall variation in the shape of the wheel bore compared to a 3D model of a nominal wheel. A large amount of distortion on the outboard side is evident. View from inboard side of wheel.

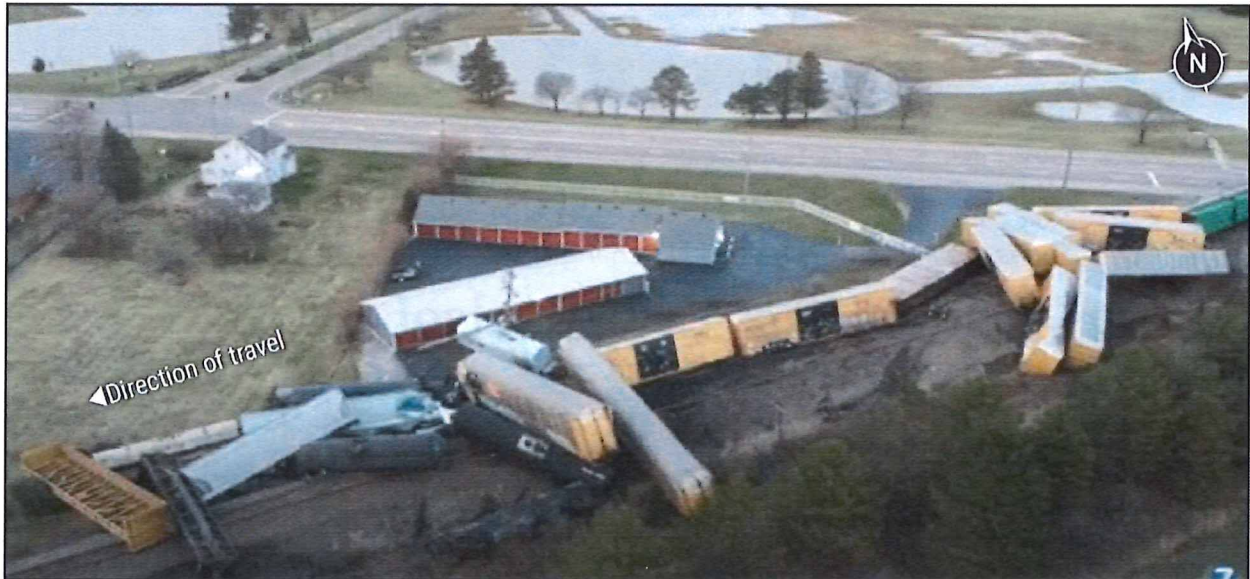
Figure. Aerial view of derailment. (Courtesy of Clark County Emergency Management Agency.)
