# The Washington Metrorail Safety Commission

## Safety Audit

of the Washington Metropolitan Area Transit Authority  
**Audit of Automatic Train Control (ATC) and Signals Program**

Final Report:  
January 18, 2024

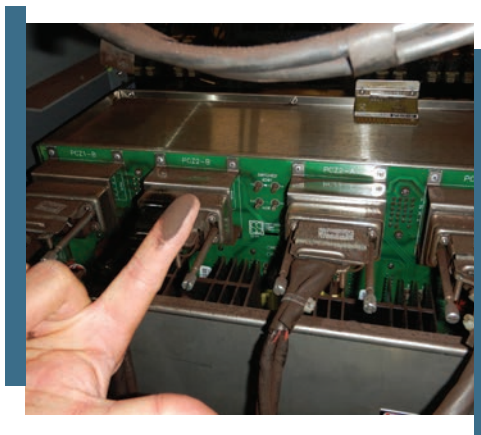
The inspections demonstrated that the conditions at the Friendship Heights Station TCR were not isolated to that location. The WMSC communicated these conditions of accumulated dust on train control equipment, failing or inoperative heating, ventilation, and air conditioning (HVAC) units, and standing water in

underground conduit housing various electronic and electrical circuitry associated with the train control equipment to Metrorail.

The accumulation of dust and debris on equipment, the long-term water intrusion into rooms, the failing HVAC ductwork or nonexistent air filtration systems, and the collapsing or otherwise damaged structural elements showed that Metrorail allowed these conditions in TCRs to deteriorate over time.

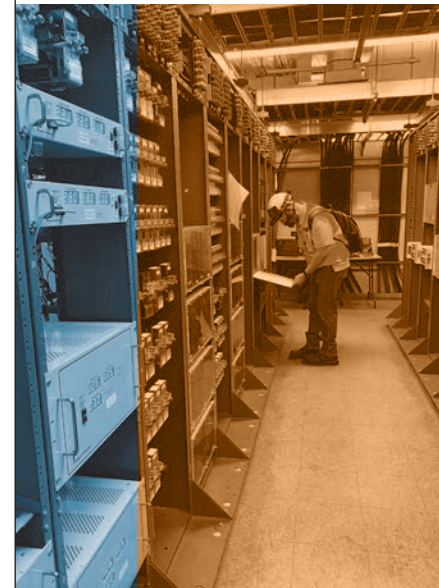
Although Metrorail procedures require weekly cleaning of each TCR, on March 28, 2022 the WMSC found the Friendship Heights Station TCR and its equipment covered in dust and other debris. The deteriorating ceiling in this room, including exposed rusting rebar and other materials, appeared to be at least one source of this debris. The TCR also had water leaks, some of which were being caught by buckets placed by Metrorail personnel, and other evidence of water intrusion. Metrorail had placed plastic over some equipment at some point in the past due to water leaks onto the equipment, but that plastic sheeting had deteriorated and was not an effective permanent mitigation. Air conditioning duct work was also deteriorated.

**The WMSC communicated the urgent safety concern identified in that room to Metrorail on March 29, 2022 and required Metrorail to take immediate action to address those safety concerns.**

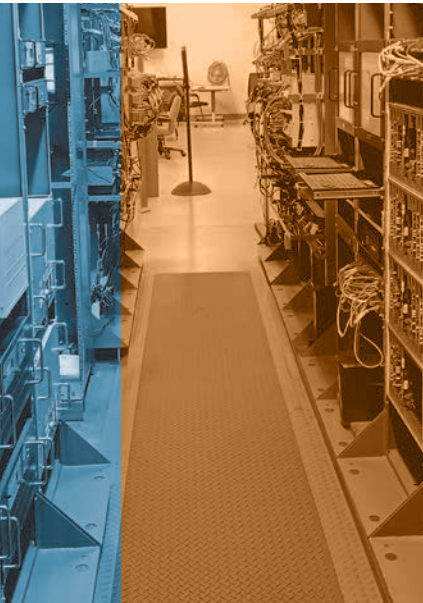
**The digital multimeter being used by ATC Maintenance personnel was not capable of measuring the required range for shunt testing designed to test whether the track circuit properly displays as occupied in the worst-case scenario of a rail vehicle's wheels making poor contact with running rails.**

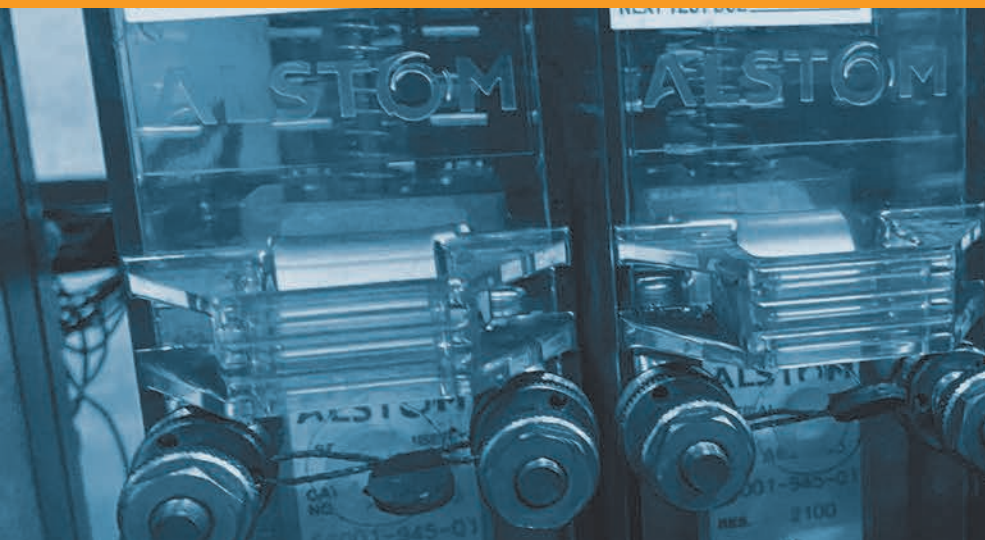
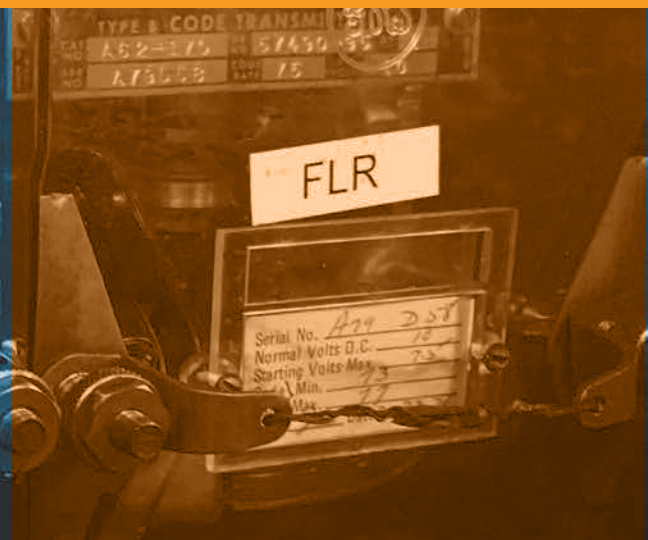
- At the time of this audit, Metrorail was testing an alternative microswitch in a Grand Master 4000 at the D&G Junction (where the Orange, Blue and Silver Lines diverge east of Stadium-Armory Station) to address some previous issues (see 2021 WMSC ATC Audit) and attempt to improve reliability. Metrorail had first tested the replacement microswitch at the Telegraph Road training facility, leading to additional adjustments before installation on mainline.

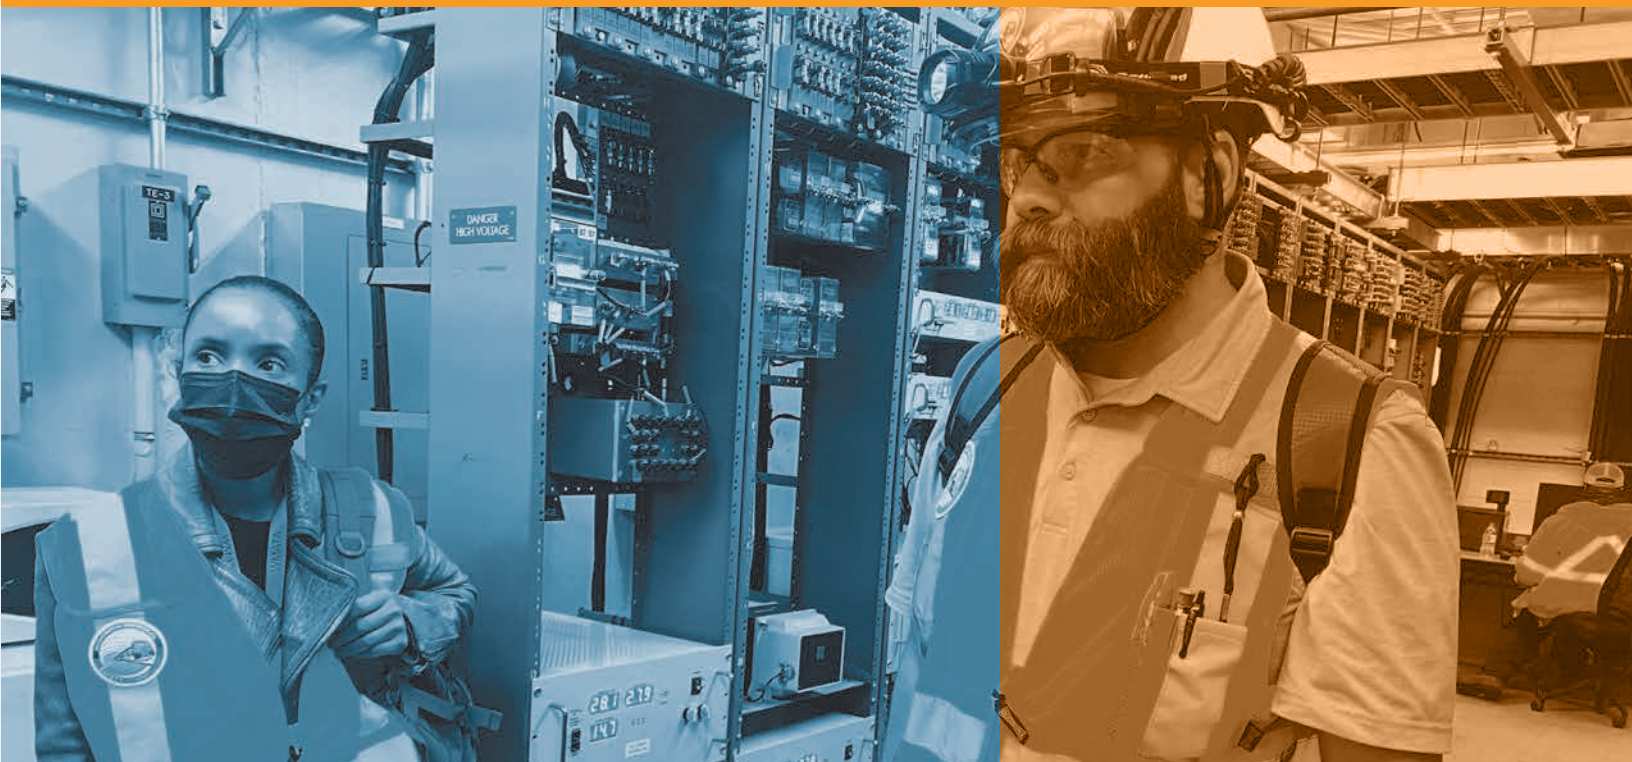
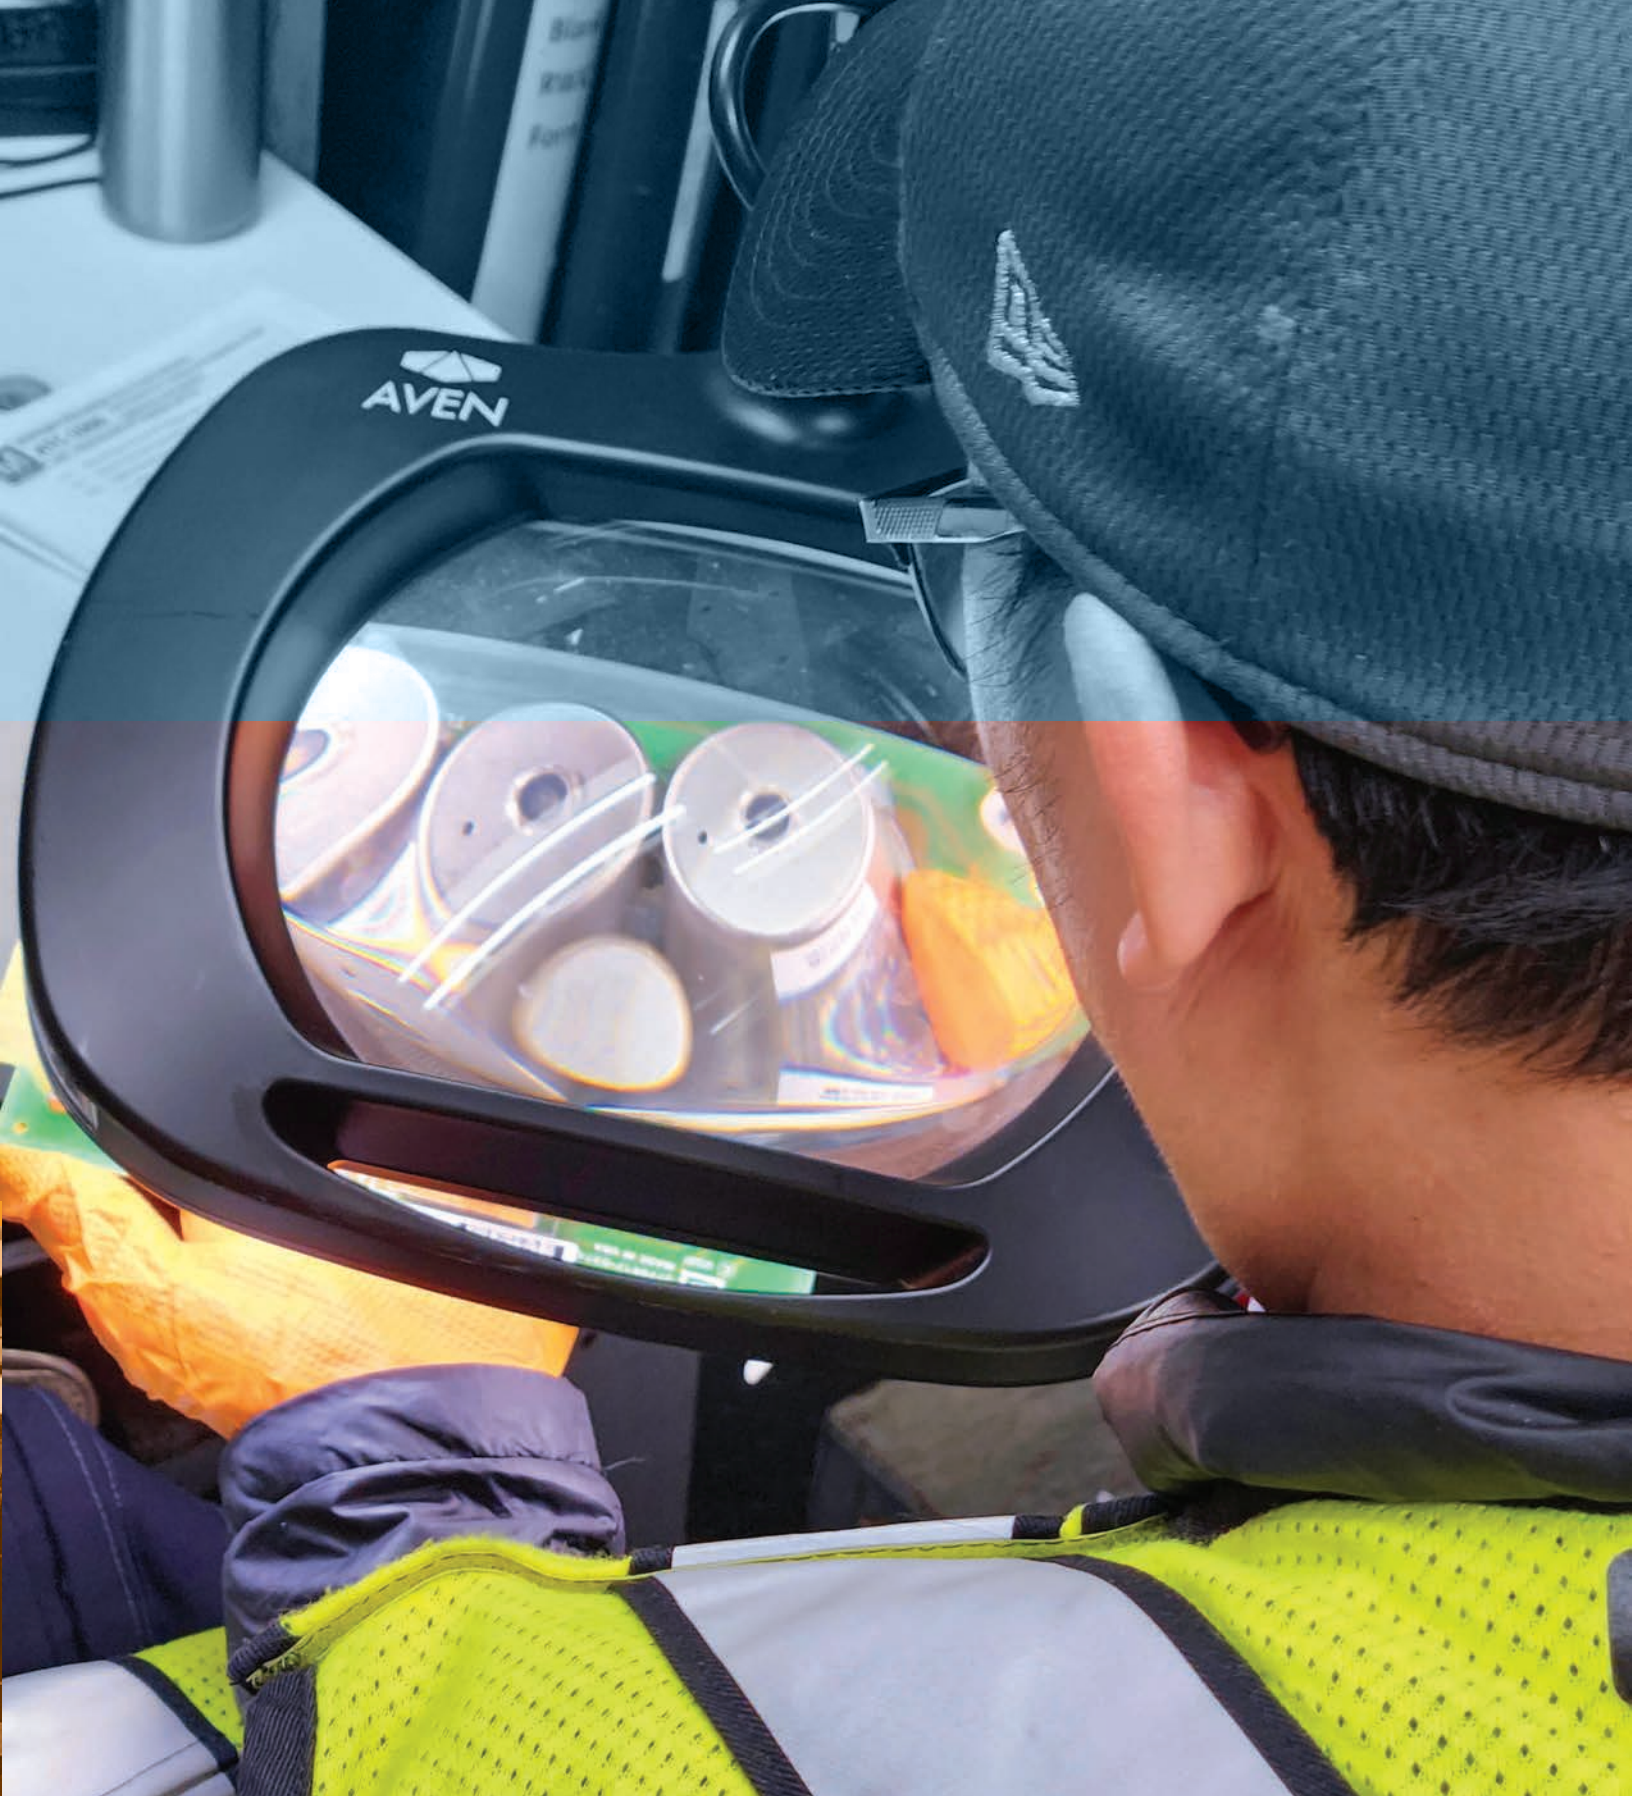
This audit demonstrated that Metrorail has made significant improvements in several locations, and some personnel stated they were getting electrostatic vacuums. However,

conditions in many other rooms remain poor. This includes rusted out power boxes, holes in ceilings, and dusty and unkempt conditions. These conditions raise concern that Metrorail still does not have effective processes to ensure that rooms and the vital equipment in them remain clean.

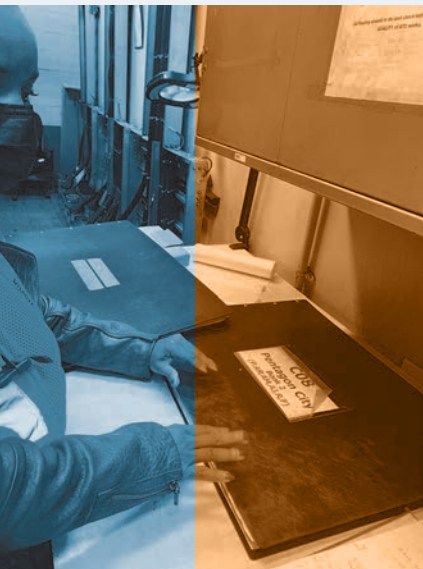
As part of this audit and other oversight activities, the WMSC reviewed Train Control Room work orders including quarterly inspections reviewed as part of Metrorail's actions under CAP C-0213 in response to the WMSC's August 4, 2022 Train Control Room maintenance and cleaning order. These inspections showed that corrective actions were needed, but Metrorail did not have documentation that the necessary corrective actions had been taken. Metrorail stated the records of mitigations and repairs were in Maximo, however WMSC review of Maximo records demonstrated the records were not. Maintenance leadership later acknowledged that evidence of any completed work should have been in Maximo, but was not. The WMSC's site-visits for this audit further demonstrated conditions remain poor in multiple Train Control Rooms, which, as also described in Finding 3, had not been fully identified in prior inspections. Metrorail procedure provides for a corrective maintenance work order to be opened to document repairs to identified issues, but Metrorail did not have such work orders and could not

provide evidence from a Metrorail system of record that items were corrected according to Metrorail's processes. After extensive WMSC follow-up, Metrorail later corrected its identified conditions and provided photos of example locations highlighted by the WMSC. Field personnel during this audit provided varying responses regarding whether Maximo work orders are opened to address issues, who ensures such a work order is opened, and what is done with associated data sheets or other documentation. The varying practices contribute to the roadblocks to Metrorail engineers or managers knowing whether all required work has been properly completed.

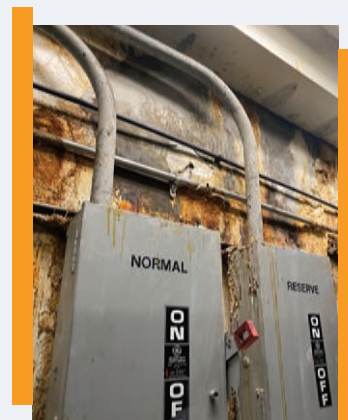
In the Rosslyn Train Control Room, in addition to significant dust build up, damaged asbestos-containing flooring (see Finding 3), and a dirty filter on an air intake that Plant Maintenance later stated did not belong there, the room temperature on the thermostat read 85 degrees Fahrenheit during the visit the morning of March 23, 2023 and the room was not cooling. Yet despite the extensive dust, dirt, and grime in the room, multiple completed forms stated that the room was clean. Duct tape was being used to hold up a switch on a power supply in a train control room equipment rack, paperwork was in disarray, and rack covers meant to protect equipment were hanging down.

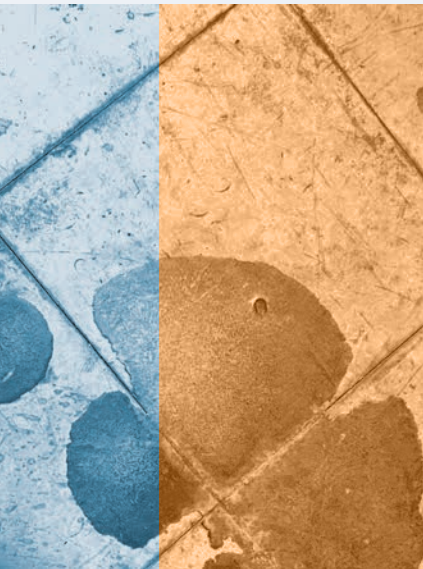
**At the Woodley Park Train Control Room, the room was hot and dirty, including dust and dirt in the card racks and cabling, there were old documents, and the floor was damaged in multiple locations.**

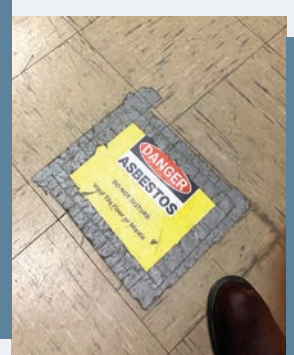
During the WMSC's on-site visits to Train Control Rooms during this audit, the audit team observed disturbed and damaged floor tiles in the Arlington Cemetery Train Control Room that Metrorail had labeled as "DANGER ASBESTOS DO NOT DISTURB Vinyl Tile Floor or Mastic." The same apparent type of tiles and mastic were also disturbed elsewhere in the room (without such signage), and those

disturbed tiles slid under the feet of personnel entering or exiting the room. There were also locations where tiles had been dislodged but evidence of the mastic (glue used to hold the tiles in place) remained and was exposed with personnel placing their full body weight on this mastic as they walked in and out of the room. This included visible changes to the condition and amount of the remaining mastic in heavy foot traffic locations.

Metrorail must complete development of and implement its Asbestos Program, including implementation for employees and contractors in such departments as Communications and Signaling, Power, Track and Structures, Plant, Safety, Information Technology and Shops and Materials Support, who may access Train Control Rooms or other ATC and Signal locations with known or possible asbestos hazards. Metrorail must assess other health hazards, such as air quality/dust and lead, identify any necessary training, protective equipment, or other mitigations, and implement such mitigations.

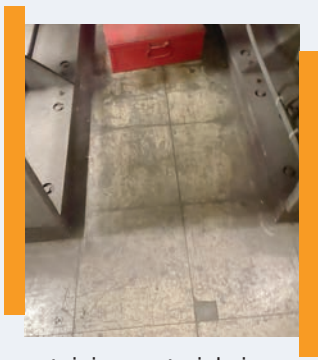
**There are still Train Control Rooms with heavy dust or other contaminants.**

Site visits for this audit show that Metrorail has improved conditions of some Train Control Rooms since the WMSC’s 2022 order. However, there are still Train Control Rooms with heavy dust or other contaminants, including significant dust that has moved through the air and built up on equipment such as significant buildup in the Rosslyn Train Control Room, and personnel expressed concerns about air quality hazards. These hazards and any associated mitigations are not included in Metrorail’s hazard log. Metrorail provided a 2017 tunnel dust assessment; however, this did not provide any information about air quality in Train Control Rooms. The 2017 assessment specifically tested locations on platforms, on mezzanines, and in station manager kiosks.

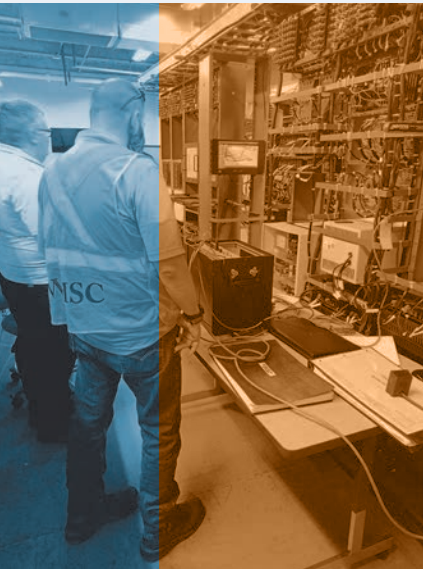
As part of interim cleaning steps for the Train Control Rooms, to address issues identified in the WMSC's August 4, 2022 Train Control Room Order, Metrorail had begun laying temporary rubber interlocking floor coverings prior to the on-site visits for this audit on top of existing tiles in some Train Control Rooms. In April and May 2023, Metrorail added this flooring in locations such as the Arlington Cemetery, Rosslyn, and Woodley Park Train Control Rooms where the WMSC observed and communicated concerns during this audit. These mats may provide some level of protection against new disturbance of the underlying materials and should make general cleaning of these areas easier. However, they do not on

their own address or mitigate the safety issues that relate to already-disturbed materials. Plant Maintenance personnel stated the matting is intended to help with cleanliness, ergonomics (non-slip), and make it easy to work on. Metrorail planned to install the matting in a total of 101 Train Control Rooms by mid-summer 2023 as an interim mitigation until a Train Control Room undergoes a capital replacement project.

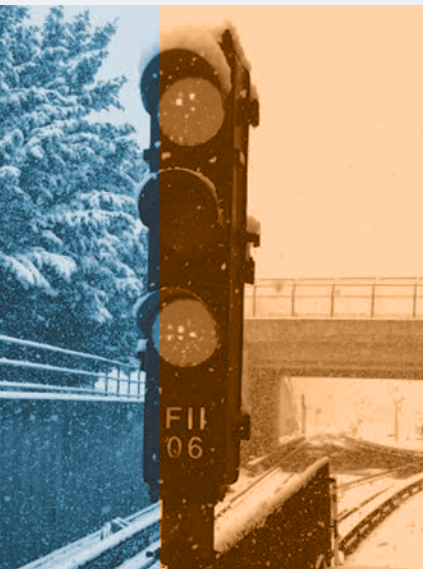
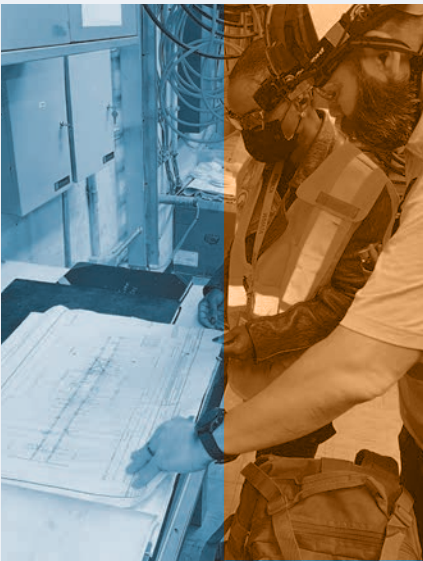
**Books of plans in Train Control Rooms provide the basis for safe and effective work in the room, particularly work related to troubleshooting or repairs.**

In the Red Line Metro Center Train Control Room, pages such as A01-G06 were damaged, and pages that the front of the book indicated should have an engineering modification instruction (EMI) recorded did not have a stamp or signature. At Branch Avenue Train Control Room, there were similar issues.

At Woodley Park Station, the book of plans had improper markings in black ink. Metrorail policy requires any markings to be made with red ink to demonstrate items added and with yellow ink to demonstrate items removed. When the WMSC pointed this out to Metrorail personnel on site, they acknowledged the deficiency.

Metrorail must review each ATC book of plans and ensure that each is in good condition with current content in accordance with Metrorail procedures. Metrorail must ensure that this review is conducted on a recurring basis as specified by Metrorail procedure.

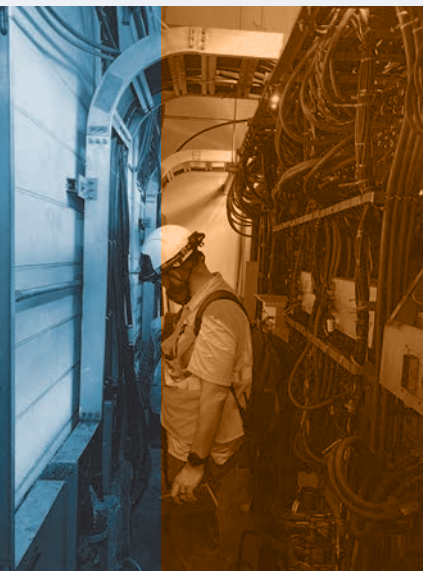
The WMSC Audit team observed temporary hang tags on wires in many Train Control Rooms that had been in place since the 1970s, 1980s and 1990s.

The WMSC Audit team observed temporary hang tags on wires in many Train Control Rooms that had been in place since the 1970s, 1980s and 1990s. As described on the tags and in interviews, Metrorail intends these blue or tan tags to indicate temporary modifications from the printed book of plans, such as the use of spare cables, that would then be replaced in the future or incorporated into permanent future updates to the books of plans used for troubleshooting and other work. However, Metrorail has no process to incorporate the information and remove these tags to provide clearer access to wiring and provide assurance that the books of plans are accurate.

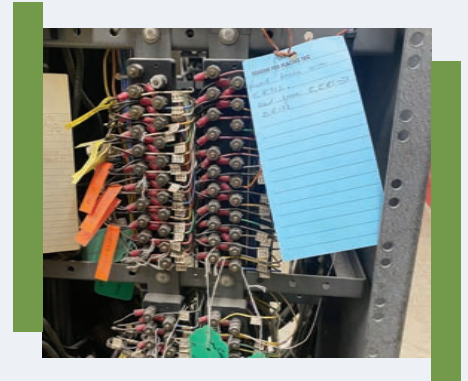
Metrorail's ATC-2000 Manual requires blue tags to be placed at each location where equipment or a circuit has been interrupted or disarranged from its configuration as drawn in the book of plans, but does not specify a process to ensure these adjustments are documented in the book of plans and removed from the room. When placing a tag, the manual states that a log book entry must explain in detail the circumstances and reasons for the changes as well as the other information required on the tag, and a work order must be opened. Log book entries and work orders from decades ago are no longer accessible for maintenance or engineering personnel, and Metrorail did not have open work orders for tags placed decades ago.
