Amtrak Passenger Train 501 Derailment
DuPont, Washington
December 18, 2017

NTSB/RAR-19/01
PB2019-100807

NTSB/RAR-19/01
PB2019-100807
Notation 58913
Report Date: May 21, 2019

Railroad Accident Report

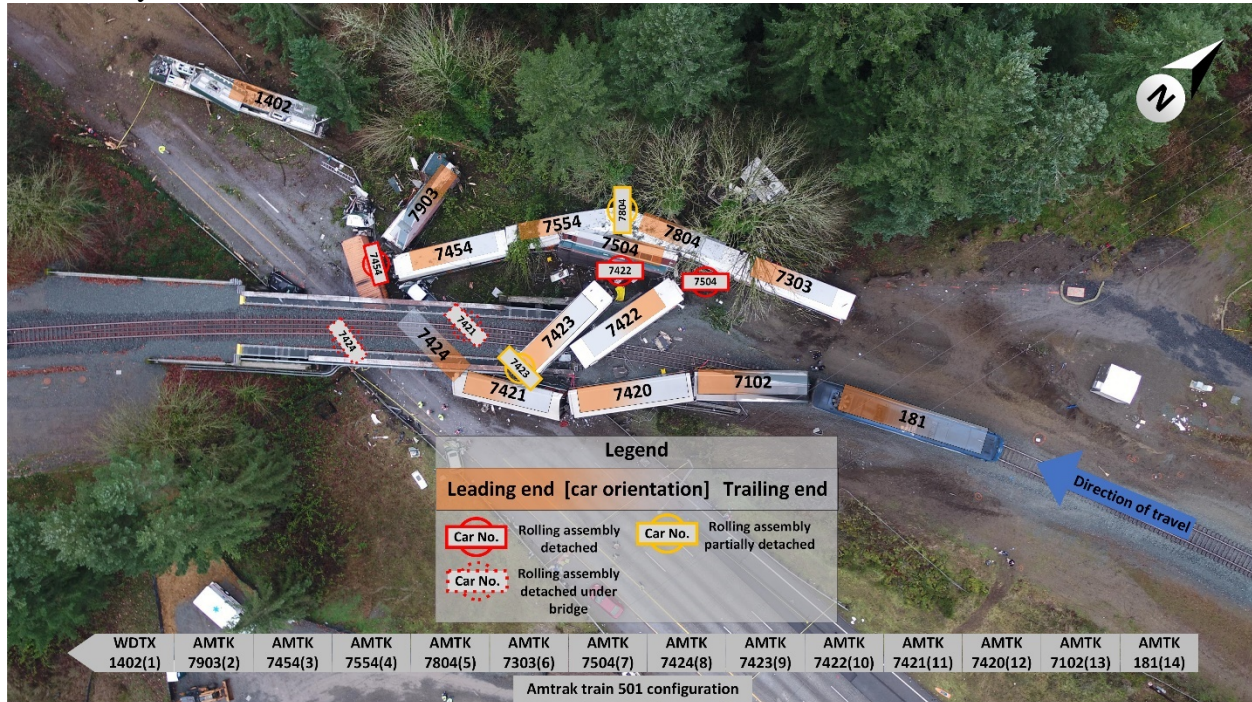
Figure 10. Overhead with railcar positions labeled. Railcar 7421 was on top of railcar 7424, which is faded because it was under the overpass. (Photo provided by WSP.)

The locomotive derailed on the high side of the curve to the right and traveled through the ballast, down the embankment through a wooded area, and came to rest at about highway mile marker 116.6 on the southbound lanes of I-5. It came to rest upright in the original direction of travel, however, the damage on the right side of the locomotive was consistent with it being on its side at some point during the derailment.

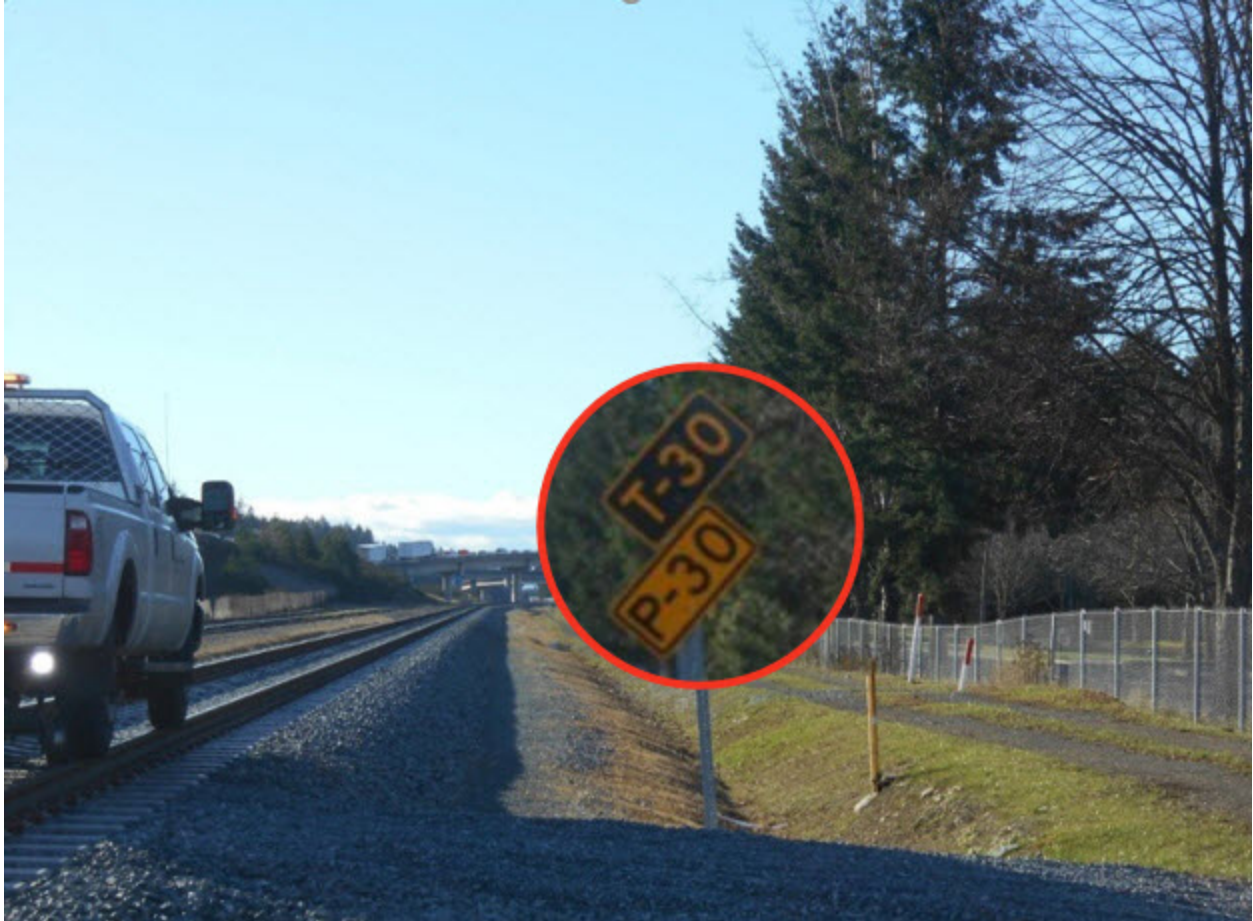
The maximum authorized speed for passenger trains on the Lakewood Subdivision was 79 mph. At MP 19.8, there was a 30-mph speed restriction for the sharp curve.⁴⁰ There was a sign at MP 19.8 to indicate the speed restriction. Two miles before reaching the curve, at MP 17.8, there were advance warning speed signs of the upcoming speed restriction. The signs “T-30” and “P-30” alerted Talgo (T) and passenger (P) operating crews that a 30-mph speed restriction entering the curve was 2 miles ahead. The advance warning signs have yellow backgrounds and black letters and/or numbers, except signs for Talgo operations have black backgrounds and yellow letters and numbers. (See figures 40 and 41.)

Figure 40. Two-mile advance warning speed sign at MP 17.8- 30 mph.
