RAIL TRANSPORTATION SAFETY INVESTIGATION REPORT R19T0147

EMPLOYEE FATALITY

Canadian National Railway Company
Remote control locomotive system
Dual hump yard assignment YDHF60
Mile 0.0, Halton Subdivision
MacMillan Yard
Vaughan, Ontario
15 August 2019

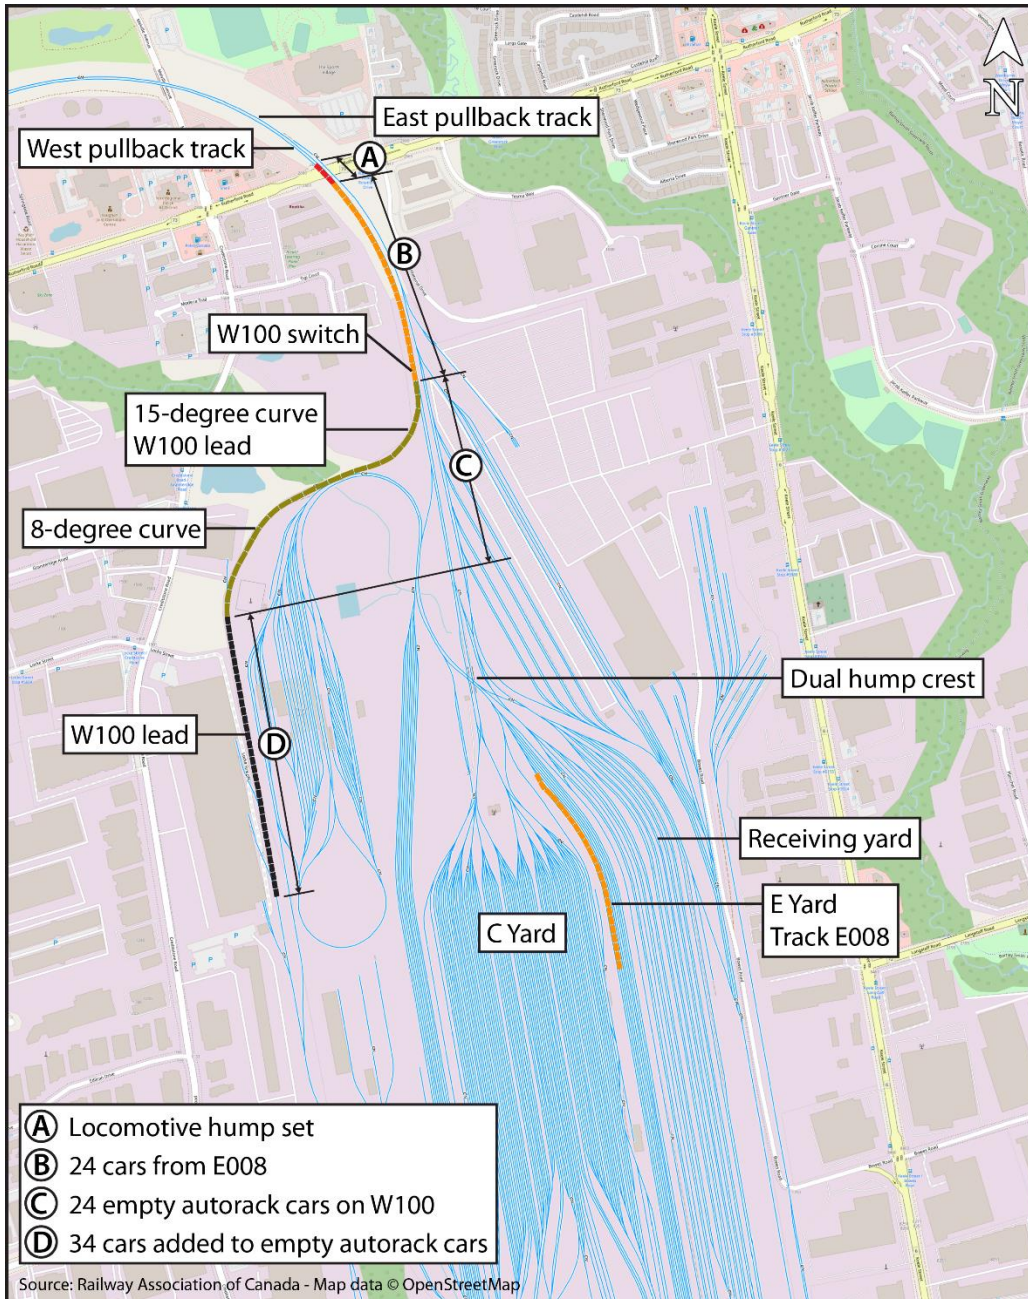
Figure 4. Layout of the north end of Canadian National Railway Company MacMillan Yard showing estimated assignment location prior to commencing northward movement (Source: Railway Association of Canada, map data from OpenStreetMap with TSB annotations)

The autorack cars were left standing at the north end of W100 and secured with a hand brake applied to each of the 3 northern-most cars. These 3 autorack cars were located along the 8-degree right-hand curve, with their A-end leading (Figure 4). Since the 3 cars were oriented the same way, each of their hand brakes was located on the north side of the track, which corresponds to the outside of the right-hand curve and the inside of the left-hand curve.

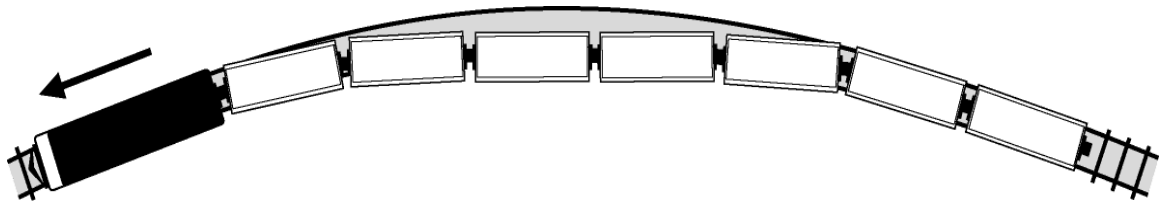
Figure 12. Pulling movement string-lining to the inside of a curve
(Source: Canadian National Railway Company)

¹³ As a train pulls through a curve, the draft (tension) forces tend to pull the wheel flanges against the inside rail of the curve. If sufficient force is present, a freight car wheel may climb, or lift, onto the head of the inside rail of a curve and derail.

The manual also identifies that the risk of string-lining increases when handling light cars within a heavy train and explains how hand or air brakes left on cars at the rear of a movement can act as an anchor. However, the manual does not include more specific guidance for identifying conditions that are conducive to string-lining, nor does it contain tips for preventing a string-line event.

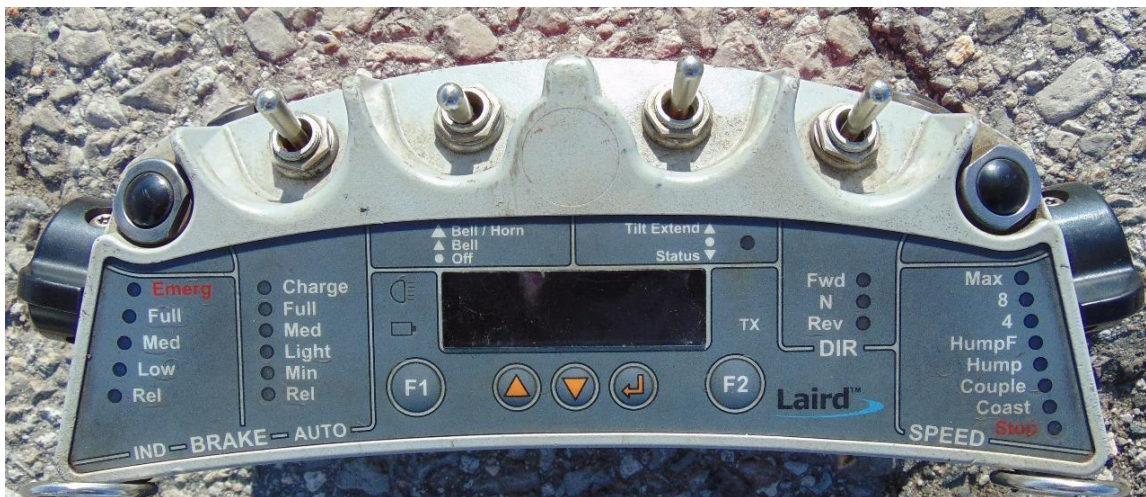
Figure 13. Operator control unit otherwise known as a Beltpack (Source: TSB)

In this case, the Beltpack involved was equipped with (but not limited to) a speed selector, a forward and reverse selector, and a brake selector that includes an emergency brake feature (Figure 13). The Beltpack was found damaged, which indicates that a loss of communication occurred.

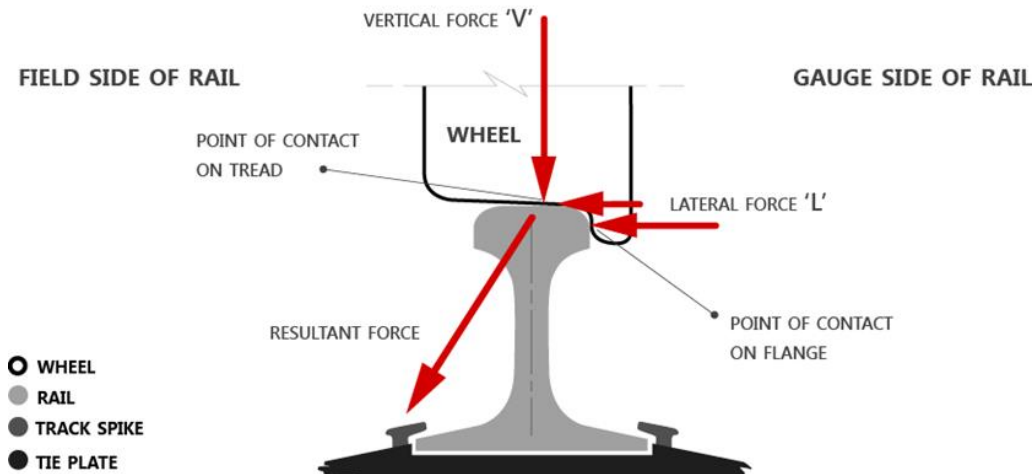
Figure 16. Lateral-to-vertical forces between wheel and rail (Source: Association of American Railroads)

A combination of lateral (L) and vertical (V) forces exists at the wheel-rail interface (Figure 16). The ratio of lateral-to-vertical (L/V) forces indicates the potential for a derailment to occur. When a high lateral force and low vertical force are present (e.g., as with an empty car), the high lateral force will tend to push the wheel flange up and over the gauge face of the rail, resulting in a wheel-climb derailment.

- A truckside L/V ratio in excess of 0.65 is indicative of the potential for a freight car truck to roll a rail and cause a derailment.
- A single-wheel L/V ratio in excess of about 0.82 is indicative of the potential for a freight car to wheel climb (or lift) on the head of a rail and cause a derailment. This can occur within about 6 feet of movement.¹⁹ When this happens, short wheel flange marks are often observed on the top of the low rail. Empty long cars equipped with long-travel EOCCDs, such as autorack cars and centrebeam bulkhead flat cars, are particularly vulnerable to these forces.
