Transportation
Safety Board
of Canada

RAIL TRANSPORTATION SAFETY INVESTIGATION REPORT R19W0002

MAIN-TRACK TRAIN COLLISION AND DERAILMENT

Canadian National Railway Company
Freight trains M31851-01 and M31541-03
Mile 50.37, Rivers Subdivision
Portage la Prairie, Manitoba
03 January 2019

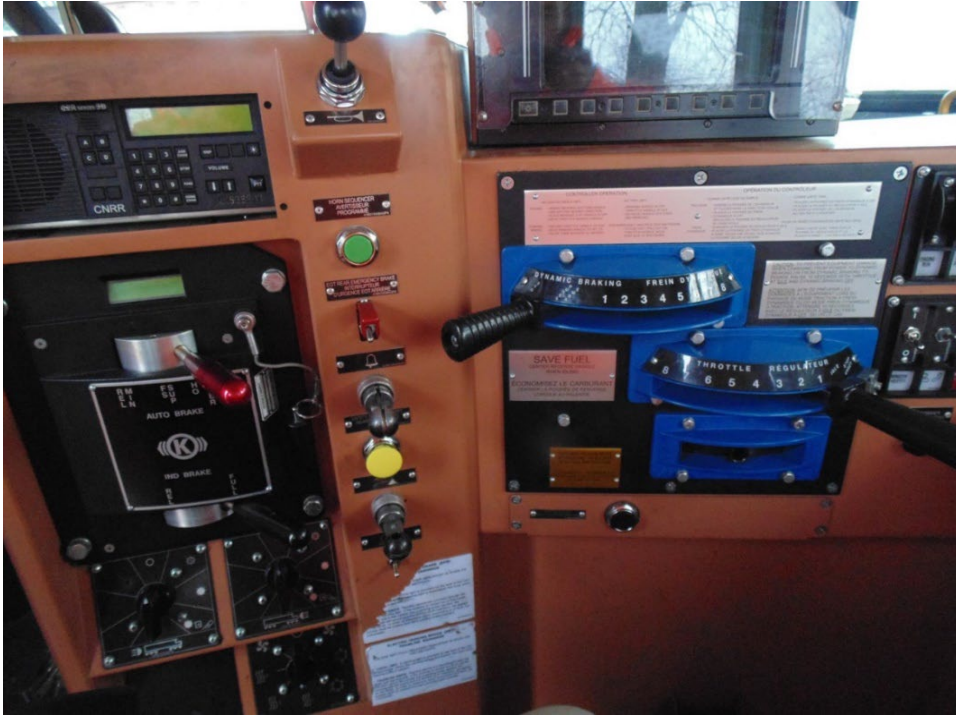
Figure 5. Typical General Electric model ET44AC locomotive control stand (Source: TSB)

CN 3009 is a General Electric model ET44AC locomotive built in August 2015, capable of producing up to 4400 HP. It is equipped with train controls placed on a control stand located to the left of the LE seat (Figure 5). The automatic brake handle is located on the left side of the control stand and is identified by the red handle.

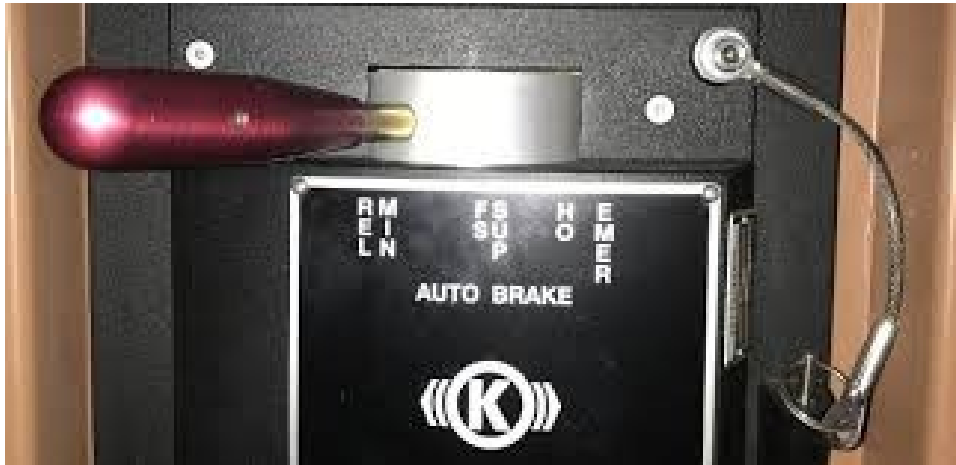
Figure 6. Locomotive automatic brake valve handle (Source: TSB)

To make a service brake application, an LE moves the automatic brake handle to the desired position (Figure 6).

Internally, the handle positions are notched so that there is a natural stop at each position; additional effort is needed to move the handle to the next position. LEs are trained to place a train into emergency by moving the automatic brake handle to the right, as far as it will go, until it encounters a stop.

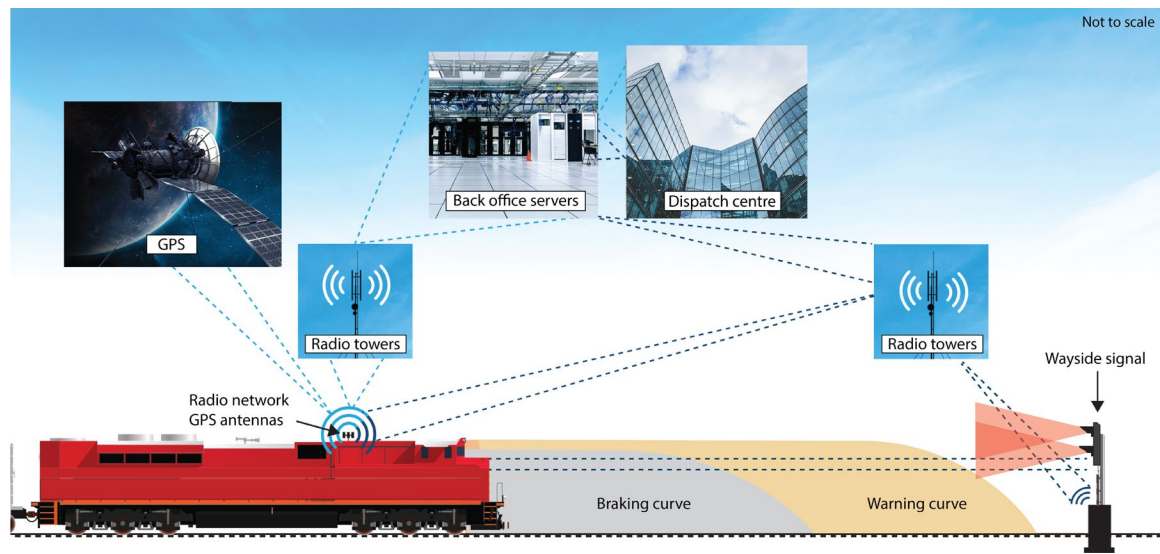
Figure 9. Schematic of PTC predictive braking curves (Source: TSB)

Once the braking curves are established, if the train speed enters the warning curve zone, an alarm is activated and an LE is expected to bring the train speed back within the braking curve zone. If the LE does not take action or the PTC system determines that the train cannot stop before the Stop signal displayed in the field, a penalty brake application occurs to stop the train (Figure 9).

During a PTC penalty brake application, PTC still calculates the train speed and the remaining stop distance, and can also initiate an emergency brake application if it deems that the full service penalty brake application is not sufficient to bring the train to a stop before reaching the Stop signal indication.

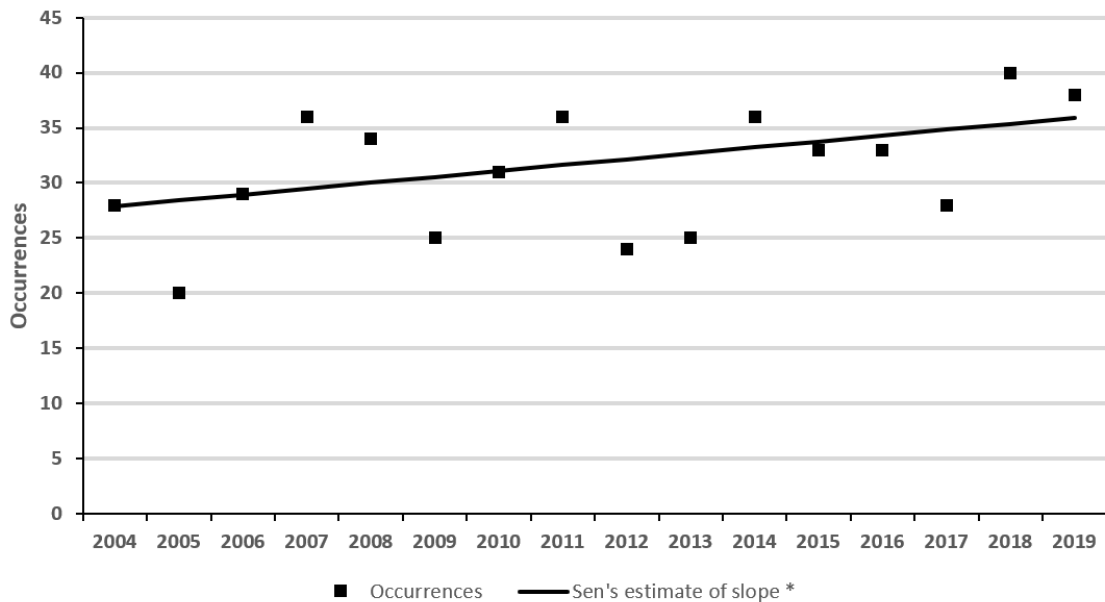
Figure 10. Rail transportation occurrences involving missed signals: number of occurrences and trend from 2004 to 2019 (Source: TSB)

From 2004 to 2019, there was an annual average of 31 reported occurrences in which a train crew did not respond appropriately to a signal indication displayed in the field, and the number of these occurrences each year is on the rise (Figure 10).

Note: Sen's estimate of slope is an unbiased estimator of the true slope of the trend line. In this chart, the Sen's estimate of slope expressed by the line indicates an upward trend in the number of occurrences over the period ($\tau_b = 0.324$, p 1-tailed = 0.0425).

The years 2018 and 2019 had the highest number of these occurrences, with 40 and 38 respectively.
