National Transportation Safety Board

Safety Recommendation Report

Placement of DOT-111 Tank Cars in High Hazard Flammable Trains and the Use of Buffer Cars for the Protection of Train Crews

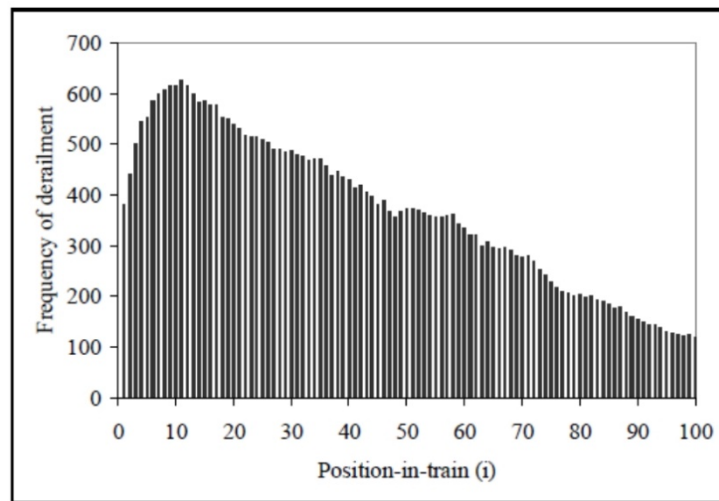
Researchers generally agree that cars positioned at the rear of a train have a lower probability of being derailed and, therefore, a lower probability of sustaining mechanical breaching damages. For example, in 2005, the researchers from the University of Illinois at Urbana-Champaign presented a report at the Heavy Haul Railway Conference in which they conducted a statistical analysis and used modeling techniques to estimate the probabilities of derailment for individual cars as affected by train length, operating speed, and their position within a consist.⁷ As shown in figure 1, a graphic from Anderson and Barkan's study, the frequency of derailment for each position in the train was obtained by counting the number of times cars in each location derailed for the study of 4,661 Class 1 railroad mainline freight train derailment accident reports for all consist lengths. The average speed of derailment for the 10-year study period was 24.8 mph. Based on this research, the positioning of the breached DOT-111 tank cars in both the Draffin, Kentucky, and Fort Worth, Texas, accidents made them two to three times more likely to derail in an accident than had they been placed near the end of the train. (See figure 1.)

Figure 1. Car frequency of derailment vs. position. (Anderson and Barkan)

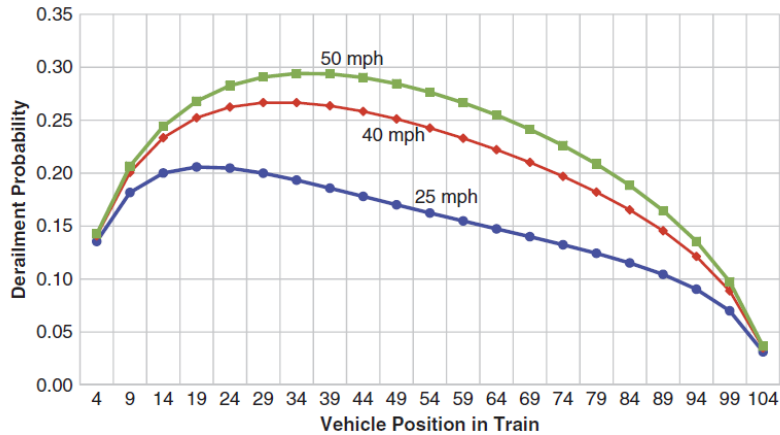
graphic from the Rutgers research, shows derailment probabilities for derailment speeds of 25, 40, and 50 mph. This research suggests that in a derailment of a 100-car unit train at 25 mph, tank cars placed near the front of the train have a 15 to 20 percent chance of derailling, whereas a tank car placed in position 99 would only have a 5 percent chance of derailling. Derailment risks are greater at the head end with increasing train speed.

Figure 2. Position-dependent car derailment probability per train derailment. (Liu)

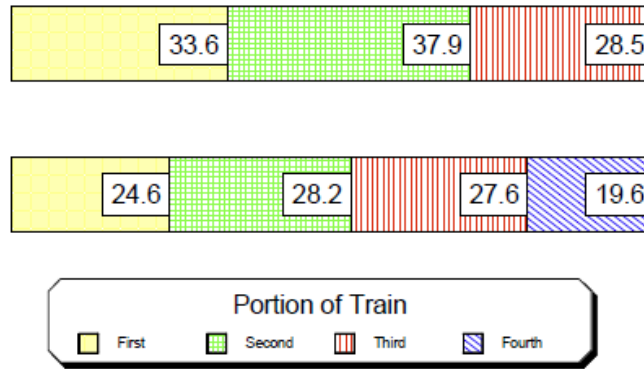
A third example of train position and derailment risk is found in a 2005 report published by the FRA.⁹ The Hazardous Materials Transportation Authorization Act of 1994 mandated that the FRA address the placement of hazardous materials cars in trains with the purpose of avoiding harm to crewmembers or interaction of hazardous materials should a train accident or other unintended release occur. The FRA report referenced data from 5,451 train derailments that occurred between 1982 and 1985 to determine the positions of derailed cars. The FRA found that the risk of derailment was significantly lower toward the rear of a train. Figure 3, from the Batelle Memorial Institute, illustrates this finding in a three- and four-section analysis of the data, showing that the risk of derailment is less in the rear of a train (right side of figure) and implies little difference in the relative safety of the first two-thirds or three-quarters.

Figure 3. Percentage of risk of cars becoming involved in a derailment based on their in-train position. (Batelle Memorial Institute)
