Railroad Investigation Report RIR-23-08

Derailment of Amtrak Passenger Train 7 on BNSF Railway Track

Joplin, Montana
September 25, 2021

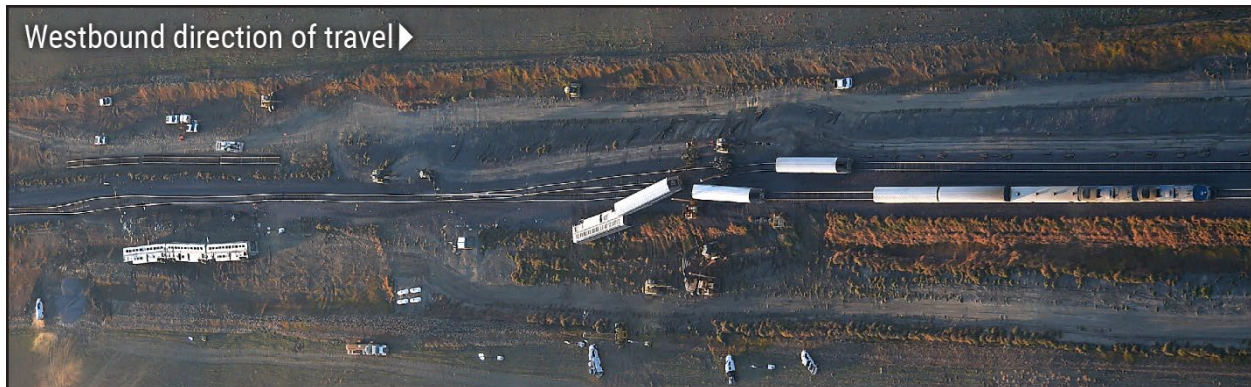
On September 25, 2021, at 3:56 p.m. local time, Amtrak (National Railroad Passenger Corporation) Passenger Train 7 (the *Empire Builder*), consisting of 2 front locomotives and 10 railcars, derailed at milepost (MP) 1014.574 on the BNSF Railway (BNSF) Hi-Line subdivision near Joplin, Montana.¹ The train was traveling west at a speed of 77 mph, which was within the authorized speed limit for passenger trains on the BNSF track, when it derailed while negotiating a slight right-hand curve while ascending a slight grade on a single main track.² After the train derailed, it traversed the east switch for the Buelow siding and came to rest on both the main and siding tracks. As a result of the accident, 8 railcars derailed, 3 passengers were killed, and 49 passengers were injured.³ (See figure 1.)

Figure 1. Aerial view of the derailment scene. Photograph courtesy of the *Billings Gazette*.

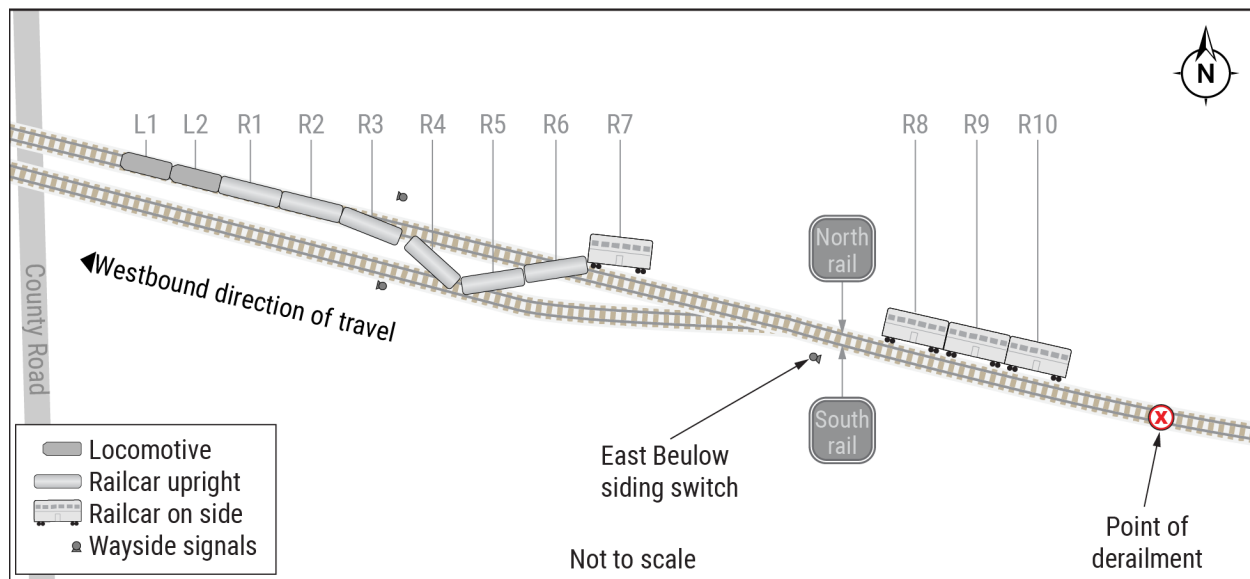
The fourth railcar in the consist, a Superliner II sleeper railcar, was the first railcar to derail. It remained upright after the derailment. The third and fifth railcars in the consist also derailed and remained upright. The sixth railcar in the consist derailed leaning. The railcars in positions seven through ten all derailed onto their right sides.

Figure 2. Site drawing of the derailment scene.
